HOME
report

SINGLE SURVEY
ENERGY REPORT
PROPERTY QUESTIONNAIRE
VALUATION REPORT

Property address	26B Kennedy Road, Troon, KA10 6BZ
-------------------------	---

Date of inspection	2nd October 2023
---------------------------	------------------

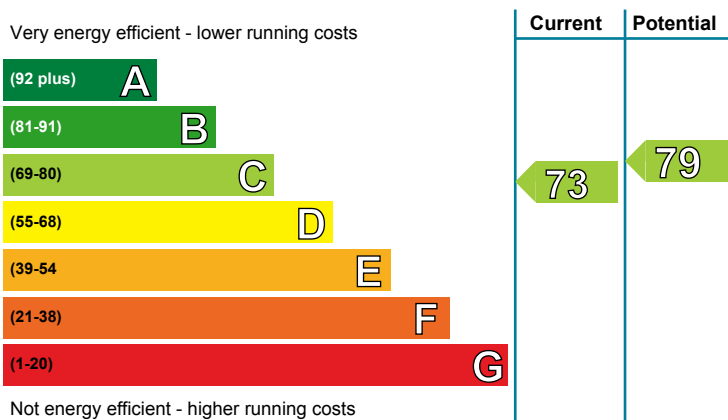
Energy Efficiency Rating

This graph shows the current efficiency of your home, taking into account both energy efficiency and fuel costs. The higher this rating, the lower your fuel bills are likely to be.

Your current rating is **band C (73)**. The average rating for EPCs in Scotland is **band D (61)**.

The potential rating shows the effect of undertaking all of the improvement measures listed within your recommendations report.
