Home Report

Scottish Single Survey

Property address	4 Carlung House Carlung Estate WEST KILBRIDE KA23 9PU
-------------------------	--

Prepared by	J & E Shepherd Chartered Surveyors
--------------------	------------------------------------

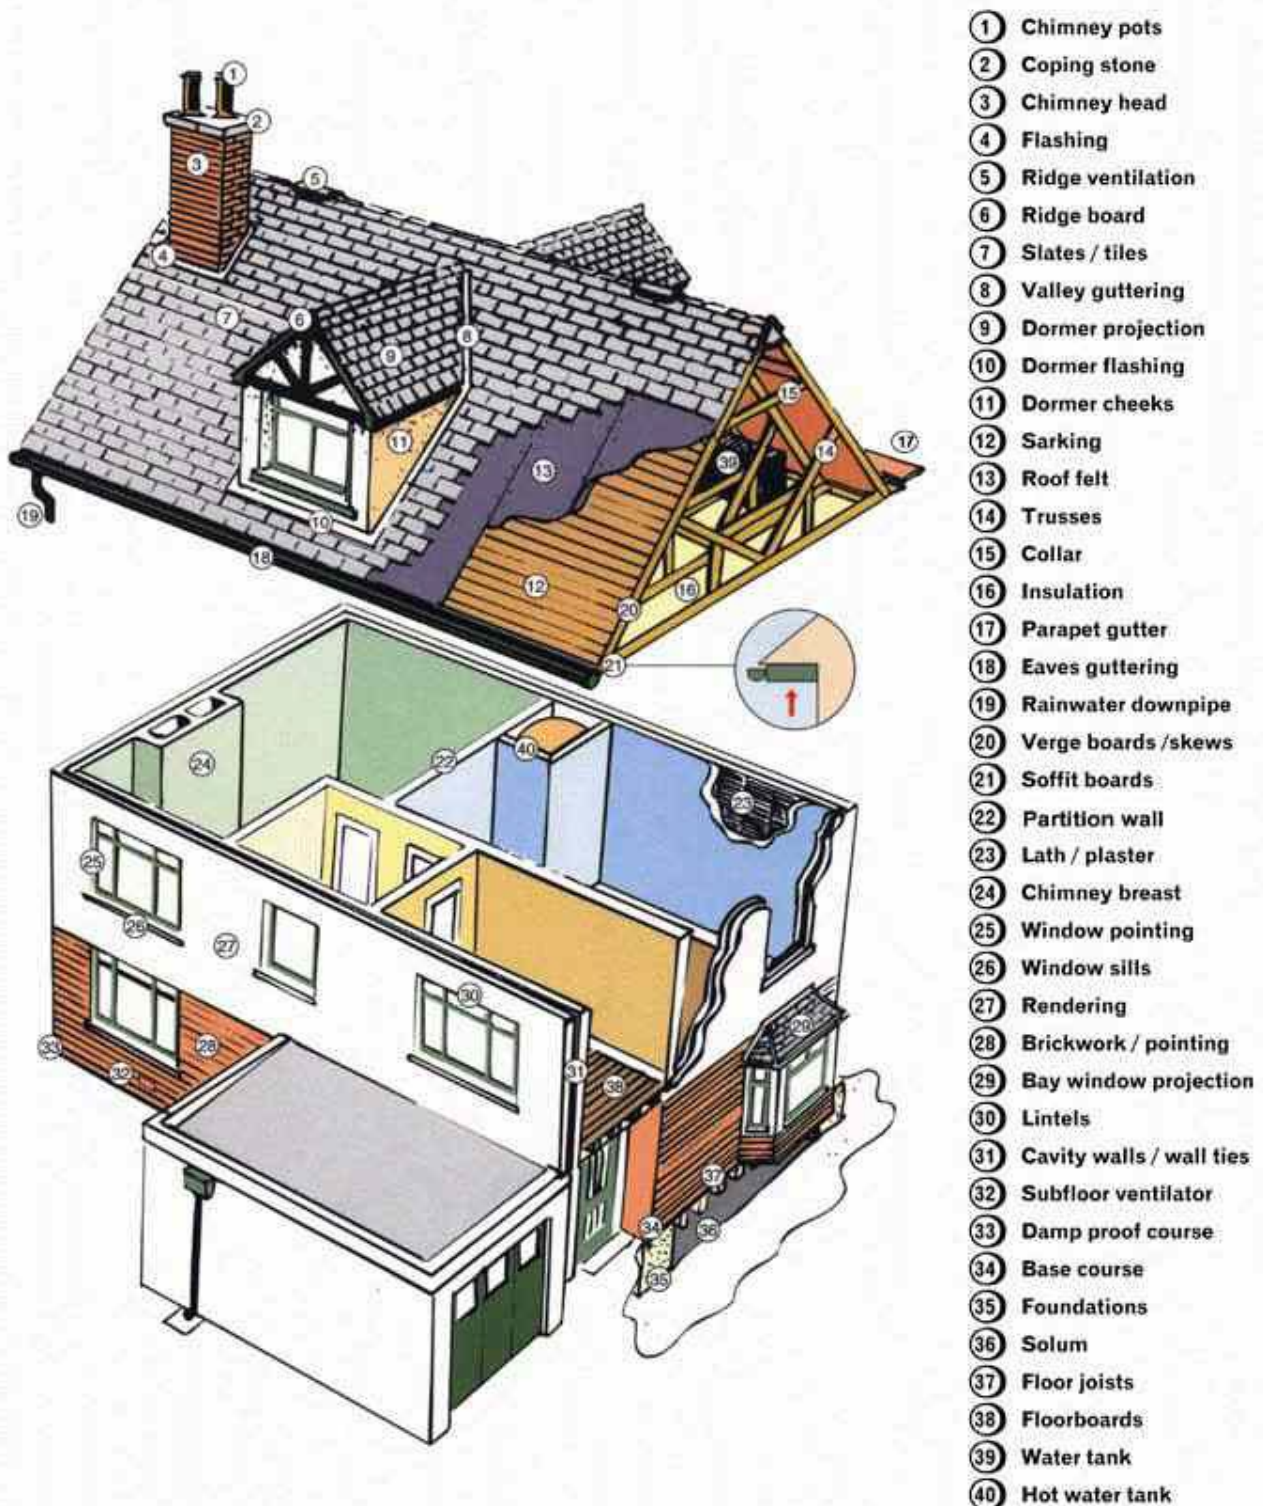
Sectional Diagram showing elements of a typical house

Reference may be made in this report to some or all of the above component parts of the property. This diagram may assist you in locating and understanding these items.

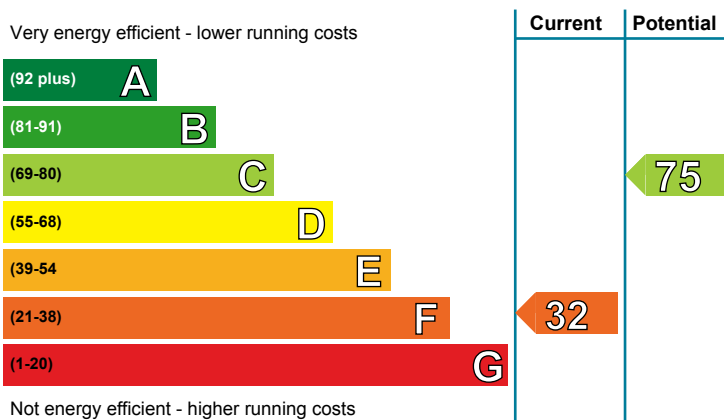
Energy Efficiency Rating

This graph shows the current efficiency of your home, taking into account both energy efficiency and fuel costs. The higher this rating, the lower your fuel bills are likely to be.

Your current rating is **band F (32)**. The average rating for EPCs in Scotland is **band D (61)**.

The potential rating shows the effect of undertaking all of the improvement measures listed within your recommendations report.

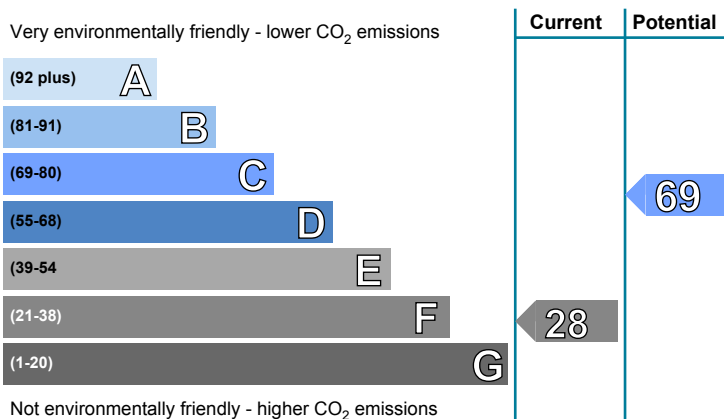
Environmental Impact (CO₂) Rating

This graph shows the effect of your home on the environment in terms of carbon dioxide (CO₂) emissions. The higher the rating, the less impact it has on the environment.
