Home Report

Single Survey

Property address	46 Castlebay Court LARGS KA30 8DS
------------------	---

Prepared by	Shepherd Chartered Surveyors
-------------	------------------------------

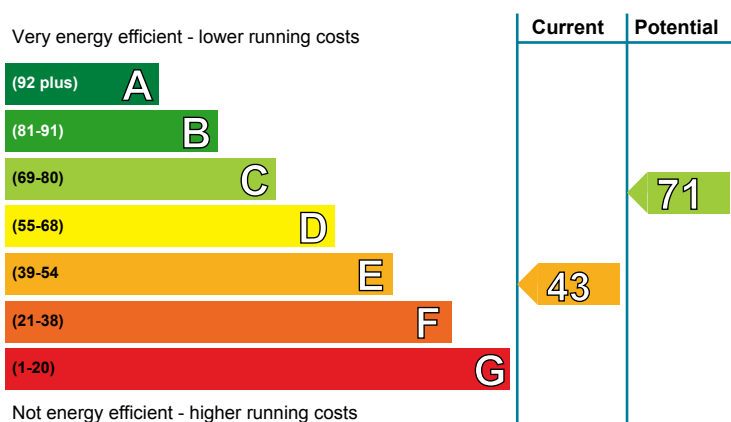
Energy Efficiency Rating

This graph shows the current efficiency of your home, taking into account both energy efficiency and fuel costs. The higher this rating, the lower your fuel bills are likely to be.

Your current rating is **band E (43)**. The average rating for EPCs in Scotland is **band D (61)**.

The potential rating shows the effect of undertaking all of the improvement measures listed within your recommendations report.

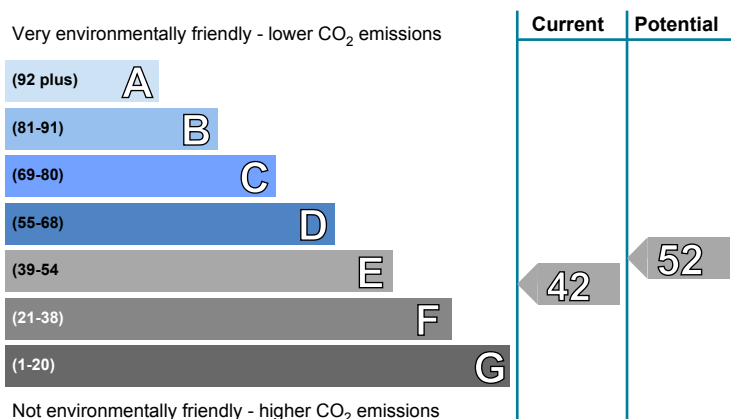
Environmental Impact (CO₂) Rating

This graph shows the effect of your home on the environment in terms of carbon dioxide (CO₂) emissions. The higher the rating, the less impact it has on the environment.
