Home Report

Scottish Single Survey

Property address	7 Lindsay Crescent LARGS KA30 9JP
-------------------------	---

Prepared by	Shepherd Chartered Surveyors
--------------------	------------------------------

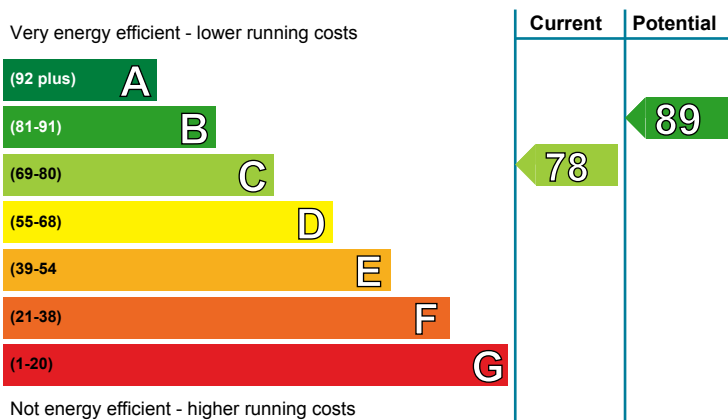
Energy Efficiency Rating

This graph shows the current efficiency of your home, taking into account both energy efficiency and fuel costs. The higher this rating, the lower your fuel bills are likely to be.

Your current rating is **band C (78)**. The average rating for EPCs in Scotland is **band D (61)**.

The potential rating shows the effect of undertaking all of the improvement measures listed within your recommendations report.
