40B TEMPLEHILL

# Home Report

40B TEMPLEHILL, TROON, KA10 6BE

# Single Survey

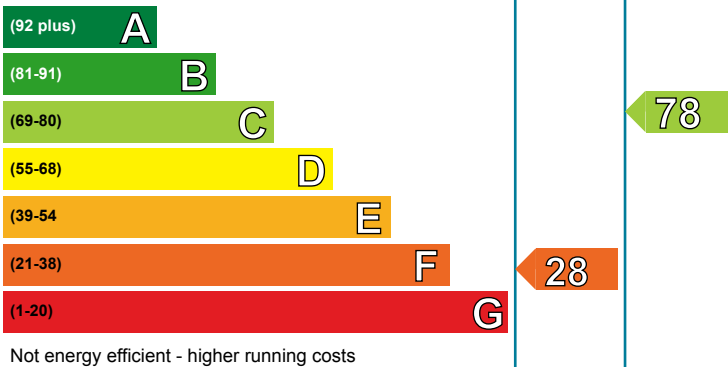
## Energy Efficiency Rating

This graph shows the current efficiency of your home, taking into account both energy efficiency and fuel costs. The higher this rating, the lower your fuel bills are likely to be.

Your current rating is **band F (28)**. The average rating for EPCs in Scotland is **band D (61)**.

The potential rating shows the effect of undertaking all of the improvement measures listed within your recommendations report.

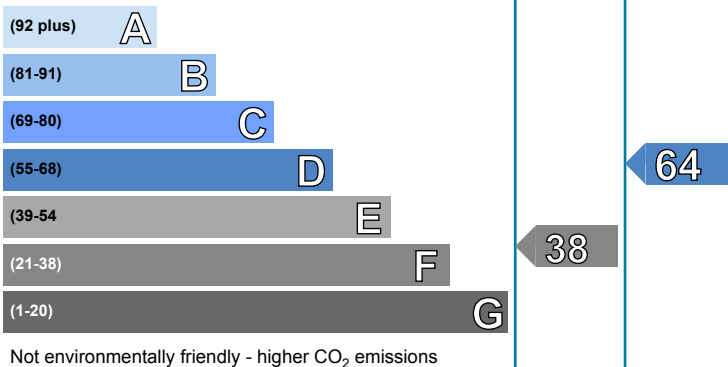
## Environmental Impact (CO<sub>2</sub>) Rating

This graph shows the effect of your home on the environment in terms of carbon dioxide (CO<sub>2</sub>) emissions. The higher the rating, the less impact it has on the environment.

The potential rating shows the effect of undertaking all of the improvement measures listed within your recommendations report.
