Home Report

Scottish Single Survey

Property address	0/2 36 Darnley Road GLASGOW G41 4NE
Customer	Mr and Mrs Muir
Customer address	0/2 36 Darnley Road GLASGOW G41 4NE
Prepared by	Shepherd Chartered Surveyors
Date of inspection	27/07/2022

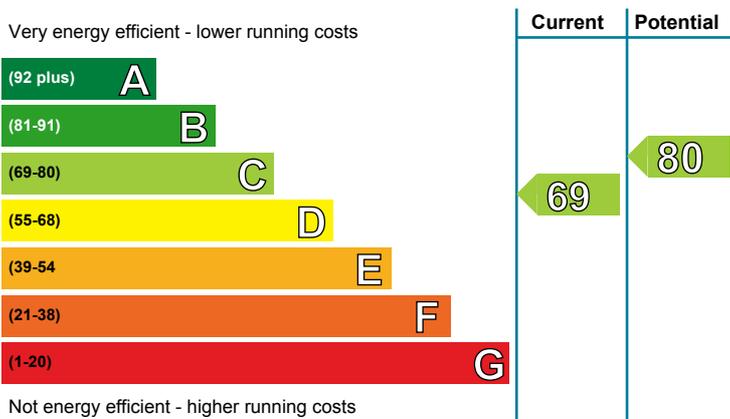
Energy Efficiency Rating

This graph shows the current efficiency of your home, taking into account both energy efficiency and fuel costs. The higher this rating, the lower your fuel bills are likely to be.

Your current rating is **band C (69)**. The average rating for EPCs in Scotland is **band D (61)**.

The potential rating shows the effect of undertaking all of the improvement measures listed within your recommendations report.

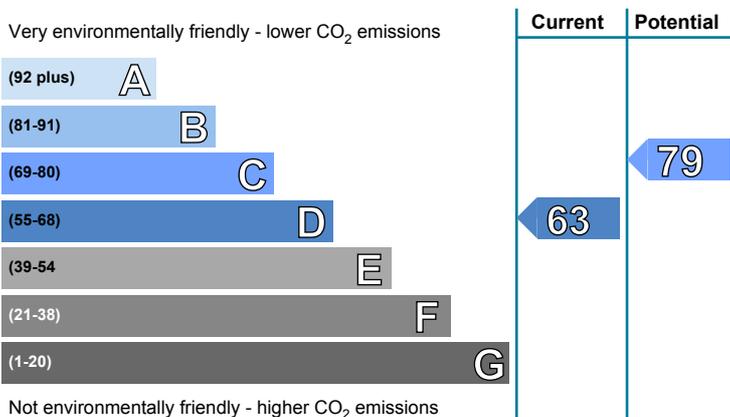
Environmental Impact (CO₂) Rating

This graph shows the effect of your home on the environment in terms of carbon dioxide (CO₂) emissions. The higher the rating, the less impact it has on the environment.
