# Home Report

# Scottish Single Survey

Property address	11 Routenburn Road LARGS KA30 8SQ
------------------	---

Prepared by	Shepherd Chartered Surveyors
-------------	------------------------------

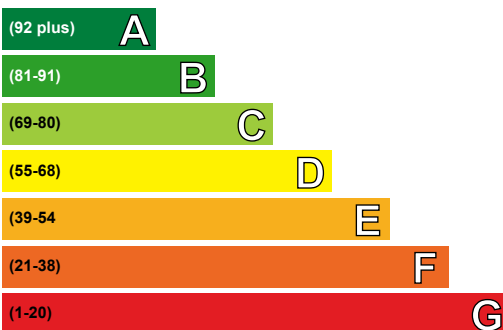
## Energy Efficiency Rating

Current	Potential
55	82

The potential rating shows the effect of undertaking all of the improvement measures listed within your recommendations report.
