# Home Report

# Scottish Single Survey

<b>Property address</b>	14 Heritage Park WEST KILBRIDE KA23 9GD
-------------------------	---

<b>Prepared by</b>	Shepherd Chartered Surveyors
--------------------	------------------------------

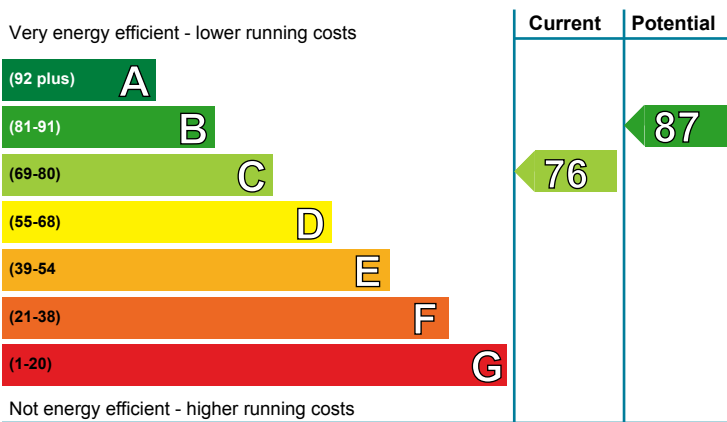
## Energy Efficiency Rating

This graph shows the current efficiency of your home, taking into account both energy efficiency and fuel costs. The higher this rating, the lower your fuel bills are likely to be.

Your current rating is **band C (76)**. The average rating for EPCs in Scotland is **band D (61)**.

The potential rating shows the effect of undertaking all of the improvement measures listed within your recommendations report.
