# Home Report

14B REGENT PARK SQUARE, GLASGOW, G41 2AG

# Scottish Single Survey

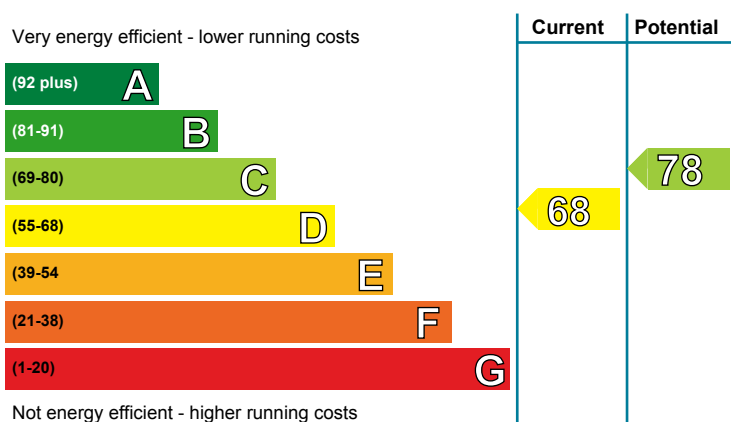
## Energy Efficiency Rating

This graph shows the current efficiency of your home, taking into account both energy efficiency and fuel costs. The higher this rating, the lower your fuel bills are likely to be.

Your current rating is **band D (68)**. The average rating for EPCs in Scotland is **band D (61)**.

The potential rating shows the effect of undertaking all of the improvement measures listed within your recommendations report.

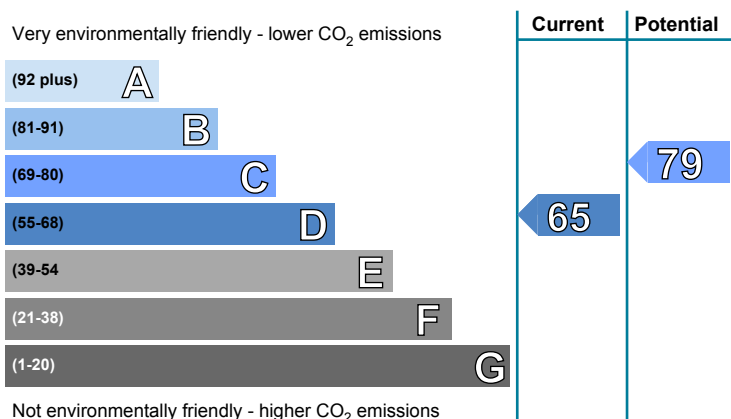
## Environmental Impact (CO<sub>2</sub>) Rating

This graph shows the effect of your home on the environment in terms of carbon dioxide (CO<sub>2</sub>) emissions. The higher the rating, the less impact it has on the environment.

Your current rating is **band D (65)**. The average rating for EPCs in Scotland is **band D (59)**.

The potential rating shows the effect of undertaking all of the improvement measures listed within your recommendations report.
