ANNEXE TURNLAW VIEW TURNLAW ROAD

Home Report

Energy Performance Certificate (EPC)

Single Survey

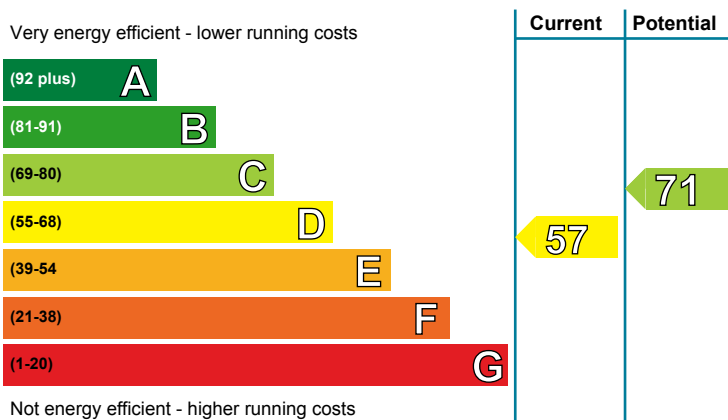
Energy Efficiency Rating

This graph shows the current efficiency of your home, taking into account both energy efficiency and fuel costs. The higher this rating, the lower your fuel bills are likely to be.

Your current rating is **band D (57)**. The average rating for EPCs in Scotland is **band D (61)**.

The potential rating shows the effect of undertaking all of the improvement measures listed within your recommendations report.
