Home Report

Scottish Single Survey

Property address	44 Glen Avenue LARGS KA30 8RB
-------------------------	-------------------------------------

Prepared by	Shepherd Chartered Surveyors
--------------------	------------------------------

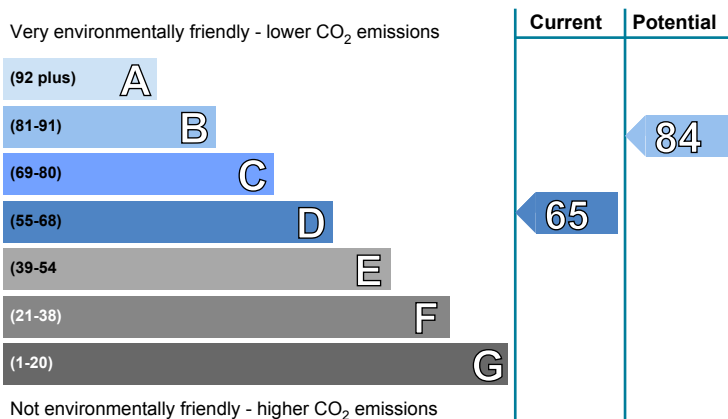
Environmental Impact (CO₂) Rating

This graph shows the effect of your home on the environment in terms of carbon dioxide (CO₂) emissions. The higher the rating, the less impact it has on the environment.
