HOME REPORT

FLAT A
50 MARYWOOD SQUARE
GLASGOW
G41 2BJ

Energy Performance Certificate (EPC)

Single Survey

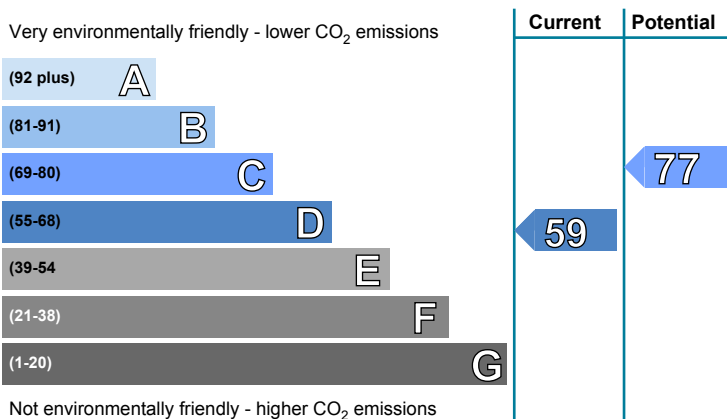
Environmental Impact (CO₂) Rating

This graph shows the effect of your home on the environment in terms of carbon dioxide (CO₂) emissions. The higher the rating, the less impact it has on the environment.

Your current rating is **band D (59)**. The average rating for EPCs in Scotland is **band D (59)**.

The potential rating shows the effect of undertaking all of the improvement measures listed within your recommendations report.
