HOME REPORT

Donegal House Middleton Farm

Irvine
KA11 2AN

Energy Performance Certificate (EPC)

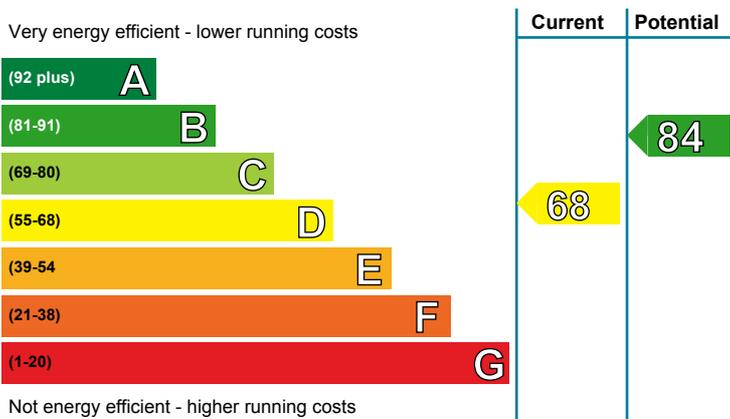
Energy Efficiency Rating

This graph shows the current efficiency of your home, taking into account both energy efficiency and fuel costs. The higher this rating, the lower your fuel bills are likely to be.

Your current rating is **band D (68)**. The average rating for EPCs in Scotland is **band D (61)**.

The potential rating shows the effect of undertaking all of the improvement measures listed within your recommendations report.

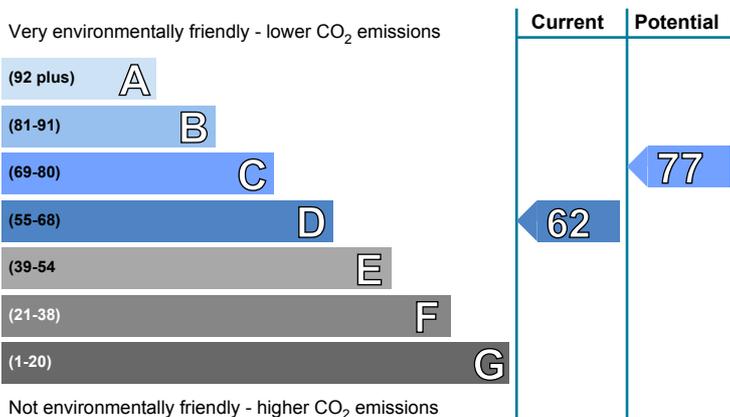
Environmental Impact (CO₂) Rating

This graph shows the effect of your home on the environment in terms of carbon dioxide (CO₂) emissions. The higher the rating, the less impact it has on the environment.

Your current rating is **band D (62)**. The average rating for EPCs in Scotland is **band D (59)**.

The potential rating shows the effect of undertaking all of the improvement measures listed within your recommendations report.
