Home Report

4 Forehill Road Ayr KA7 3DT

single survey

survey report on:

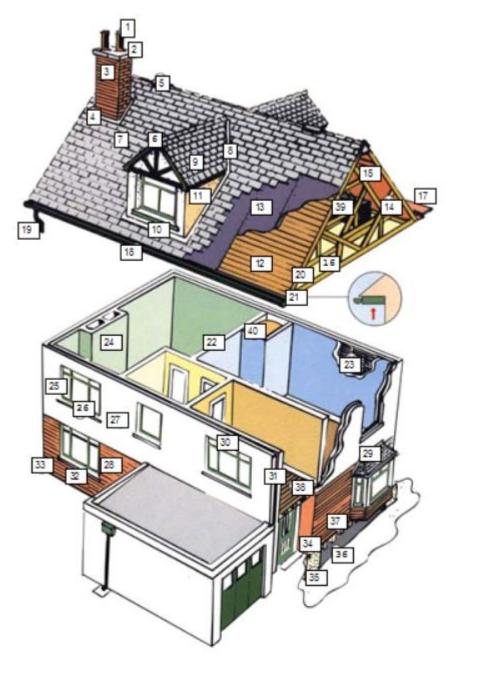
Sectional Diagram showing elements of a typical house

2 Coping stone 3 Chimney head Flashing 4 Ridge ventilation 5 Ridge board 6 7 Slates/tiles 8 Valley guttering 9 Dormer projection Dormer flashing 10 Dormer cheeks 11 12 Sarking Roof felt 13 Trusses 14 15 Collar 16 Insulation 17 Parapet gutter Eaves guttering 18 Rainwater downpipe 19 20 Verge boards / skews 21 Soffit boards 22 Partition wall Lath / plaster 23 24 Chimney breast 25 Window pointing Window sills 26 Rendering 27 Brickwork / pointing 28 Bay window 29 30 Lintels 31 Cavity walls / wall ties Subfloor ventilator 32 33 Damp proof course 34 Base course 35 Foundations Solum 36 37 Floor joists Floorboards 38 Water tank 39 40 Hot water tank
