YOUR ONESURVEY
HOME REPORT

17 Blanford Avenue
Prestwick
KA9 2BS

SINGLE SURVEY

A report on the condition of the property, with categories
being rated from 1 to 3.

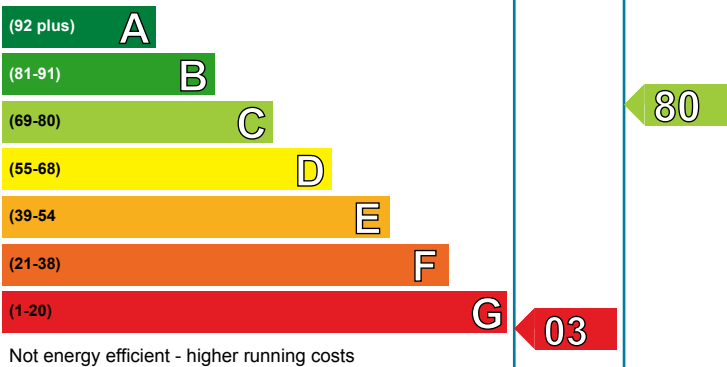
Energy Efficiency Rating

This graph shows the current efficiency of your home, taking into account both energy efficiency and fuel costs. The higher this rating, the lower your fuel bills are likely to be.

The potential rating shows the effect of undertaking all of the improvement measures listed within your recommendations report.

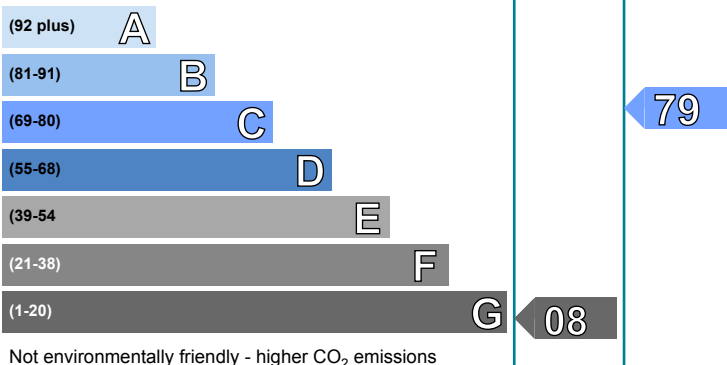
Environmental Impact (CO₂) Rating

This graph shows the effect of your home on the environment in terms of carbon dioxide (CO₂) emissions. The higher the rating, the less impact it has on the environment.
