YOUR ONESURVEY  
**HOME REPORT**

2/7  
2 Lilybank Terrace  
Hillhead  
Glasgow  
G12 8RX

# SINGLE SURVEY

# Single Survey

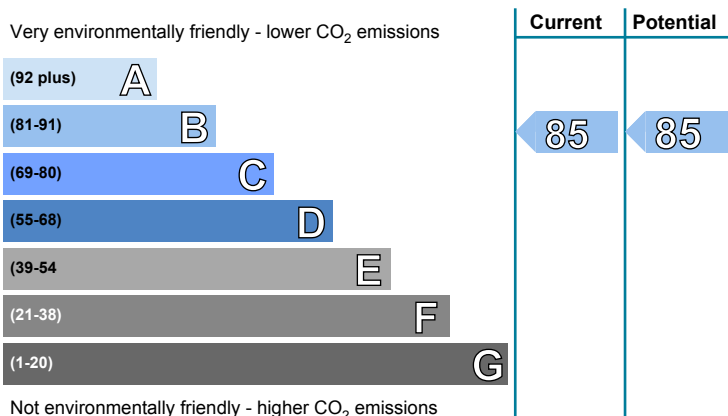
## Environmental Impact (CO<sub>2</sub>) Rating

This graph shows the effect of your home on the environment in terms of carbon dioxide (CO<sub>2</sub>) emissions. The higher the rating, the less impact it has on the environment.
