YOUR ONESURVEY  
**HOME REPORT**

Flat 1/1  
68 Montague Street  
Glasgow  
G4 9EY

# SINGLE SURVEY

A report on the condition of the property, with categories  
being rated from 1 to 3.

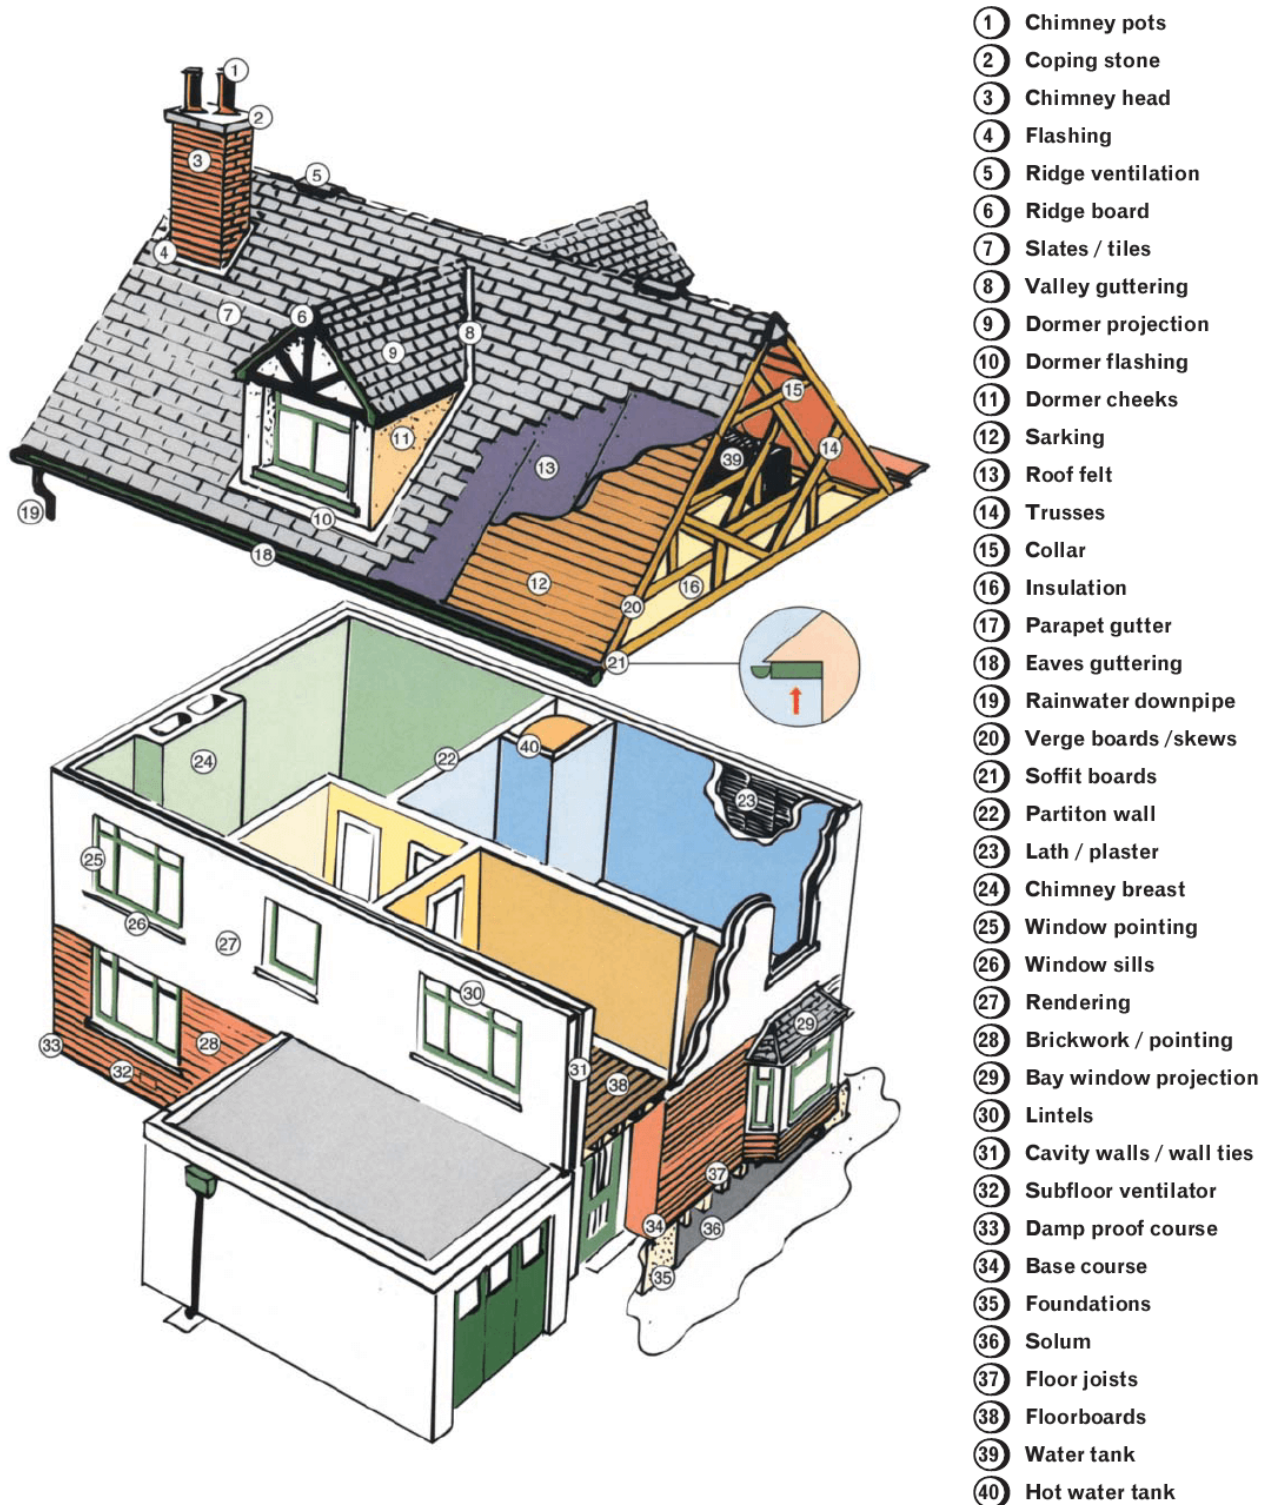
## Sectional Diagram showing elements of a typical house

Reference may be made in this report to some or all of the above component parts of the property. This diagram may assist you in locating and understanding these items.
