HOME REPORT

31 JOHN STREET
LARGS
KA30 8HY

ENERGY PERFORMANCE CERTIFICATE

SINGLE SURVEY

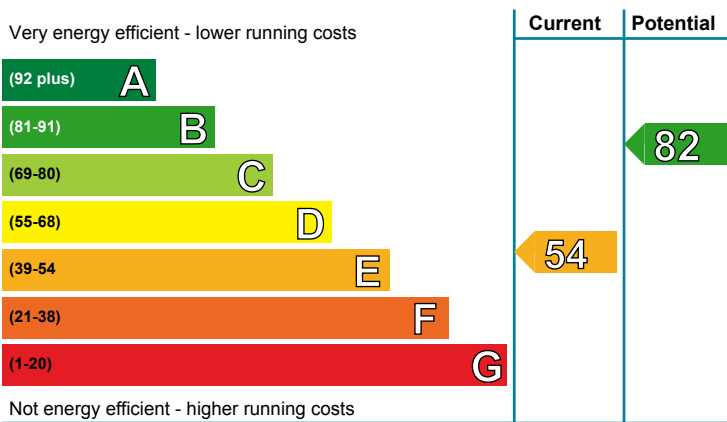
Energy Efficiency Rating

This graph shows the current efficiency of your home, taking into account both energy efficiency and fuel costs. The higher this rating, the lower your fuel bills are likely to be.

Your current rating is **band E (54)**. The average rating for EPCs in Scotland is **band D (61)**.

The potential rating shows the effect of undertaking all of the improvement measures listed within your recommendations report.
