- 1. Single Survey
- 2. Energy Report
- 3. Property Questionnaire

survey report on:

Property address	593 Clarkston Road, Netherlee, Glasgow, G44 3QD
Customer	Mr P Davison & Mrs C Davison
Customer address	
Prepared by	Harvey Donaldson And Gibson
Date of inspection	18th May 2023

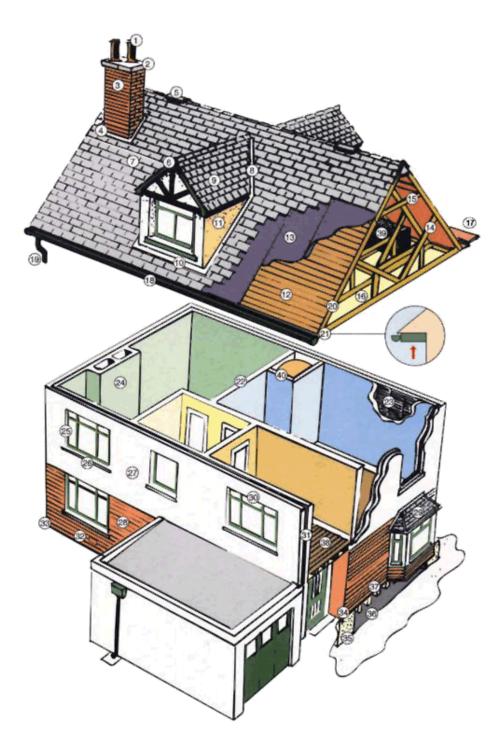
Sectional Diagram showing elements of a typical house

Reference may be made in this report to some or all of the above component parts of the property. This diagram may assist you in locating and understanding these items.

- 1) Chimney pots
- 2) Coping stone
- 3) Chimney head
- 4 Flashing
- 5) Ridge ventilation
- 6 Ridge board
- 7) Slates / tiles
- 8 Valley guttering
- 9) Dormer projection
- 10 Dormer flashing
- 11) Dormer cheeks
- (12) Sarking
- (13) Roof felt
- (14) Trusses
- 15) Collar
- (16) Insulation
- (17) Parapet gutter
- (18) Eaves guttering
- 19) Rainwater downpipe
- 20) Verge boards /skews
- 21) Soffit boards
- 22) Partition wall
- 23) Lath / plaster
- 24) Chimney breast
- 25) Window pointing
- 6) Window sills
- 27) Rendering
- (28) Brickwork / pointing
- 29) Bay window projection
- 30 Lintels
- (31) Cavity walls / wall ties
- 32) Subfloor ventilator
- 33 Damp proof course
- 34) Base course
- 35) Foundations
- 36) Solum
- Floor joists
- 38) Floorboards
- 39) Water tank
- 40 Hot water tank
