Home Report

Scottish Single Survey

Property address	3 Sunnyside Drive Clarkston Glasgow G76 7PT
-------------------------	--

Prepared by	Shepherd Chartered Surveyors
--------------------	------------------------------

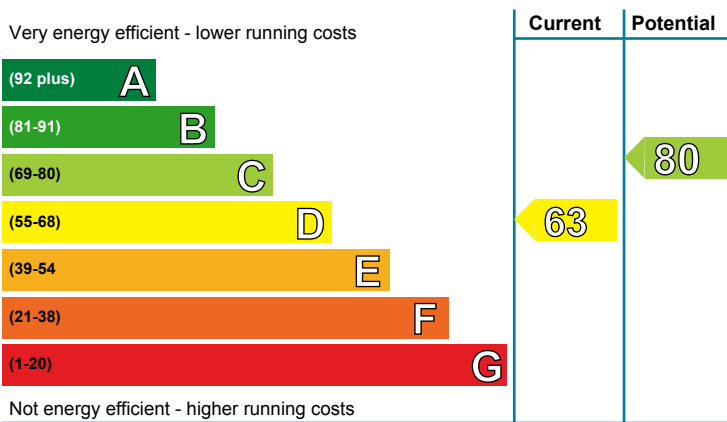
Energy Efficiency Rating

This graph shows the current efficiency of your home, taking into account both energy efficiency and fuel costs. The higher this rating, the lower your fuel bills are likely to be.

Your current rating is **band D (63)**. The average rating for EPCs in Scotland is **band D (61)**.

The potential rating shows the effect of undertaking all of the improvement measures listed within your recommendations report.
