# Home Report

## Scottish Single Survey

### survey report on:

Property address	33 Duart Avenue Prestwick KA9 1NA
Customer	Mr I Stewart (Executor)
-	
Customer address	33 Duart Avenue Prestwick KA9 1NA
Prepared by	Shepherd Chartered Surveyors
Date of inspection	07/08/2023

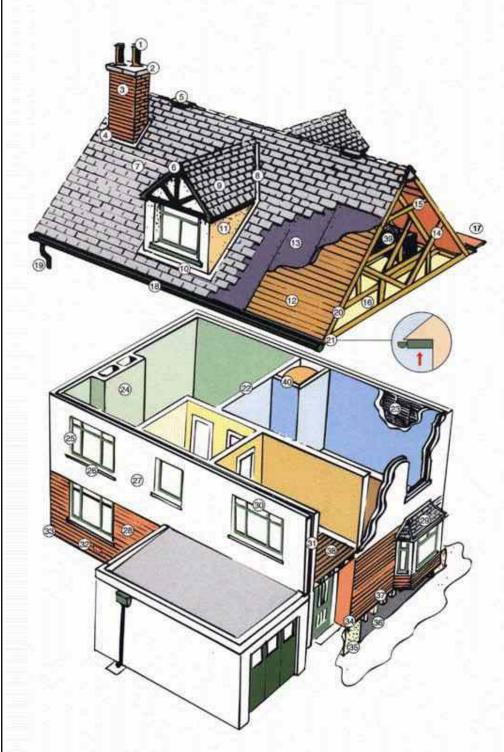
### Sectional Diagram showing elements of a typical house

Reference may be made in this report to some or all of the above component parts of the property. This diagram may assist you in locating and understanding these items.

- 1) Chimney pots
- 2) Coping stone
- 3 Chimney head
- (4) Flashing
- 5) Ridge ventilation
- (6) Ridge board
- (7) Slates / tiles
- 8 Valley guttering
- Dormer projection
- 10 Dormer flashing
- 11) Dormer cheeks
- (12) Sarking
- (13) Roof felt
- 14) Trusses
- 15) Collar
- 16) Insulation
- 17) Parapet gutter
- 18) Eaves guttering
- (19) Rainwater downpipe
- 20) Verge boards/skews
- 21) Soffit boards
- 22) Partition wall
- 23) Lath / plaster
- (24) Chimney breast
- 25) Window pointing
- 26) Window sills
- 27) Rendering
- 28) Brickwork / pointing
- 29) Bay window projection
- (30) Lintels
- (31) Cavity walls / wall ties
- 32) Subfloor ventilator
- 33) Damp proof course
- (34) Base course
- 35) Foundations
- 36) Solum
- 37) Floor joists
- 38) Floorboards
- 9) Water tank
- (40) Hot water tank
