Home Report

Scottish Single Survey

Property address	57 Dalmellington Road Glasgow G53 7FJ
Customer	PAULINE AND RICHARD JARVIS
Customer address	57 Dalmellington Road Glasgow G53 7FJ
Prepared by	Shepherd Chartered Surveyors
Date of inspection	06/09/2023

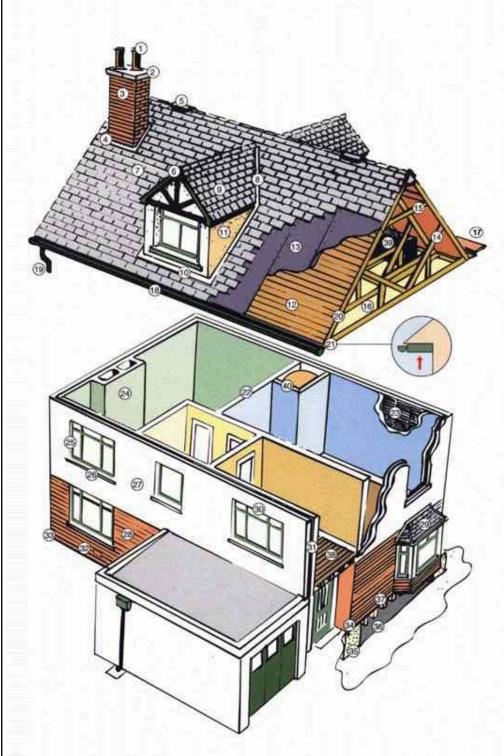
Sectional Diagram showing elements of a typical house

Reference may be made in this report to some or all of the above component parts of the property. This diagram may assist you in locating and understanding these items.

- 1) Chimney pots
- 2) Coping stone
- 3 Chimney head
- (4) Flashing
- 5) Ridge ventilation
- 6 Ridge board
- (7) Slates / tiles
- 8 Valley guttering
- 9 Dormer projection
- 10 Dormer flashing
- 11) Dormer cheeks
- (12) Sarking
- (13) Roof felt
- 14) Trusses
- (15) Collar
- 16) Insulation
- (17) Parapet gutter
- 18) Eaves guttering
- (19) Rainwater downpipe
- 20) Verge boards/skews
- 21) Soffit boards
- 22) Partition wall
- 23) Lath / plaster
- (24) Chimney breast
- 25) Window pointing
- 26) Window sills
- 27) Rendering
- 28) Brickwork / pointing
- 29 Bay window projection
- (30) Lintels
- (31) Cavity walls / wall ties
- 32) Subfloor ventilator
- (33) Damp proof course
- 34) Base course
- (35) Foundations
- 36) Solum
- 37) Floor joists
- 38) Floorboards
- 9) Water tank
- (40) Hot water tank
