YOUR ONESURVEY
HOME REPORT

Flat 0/2/R
19 Westbourne Gardens
Hyndland
Glasgow
G12 9UL

HOME REPORT

SINGLE SURVEY

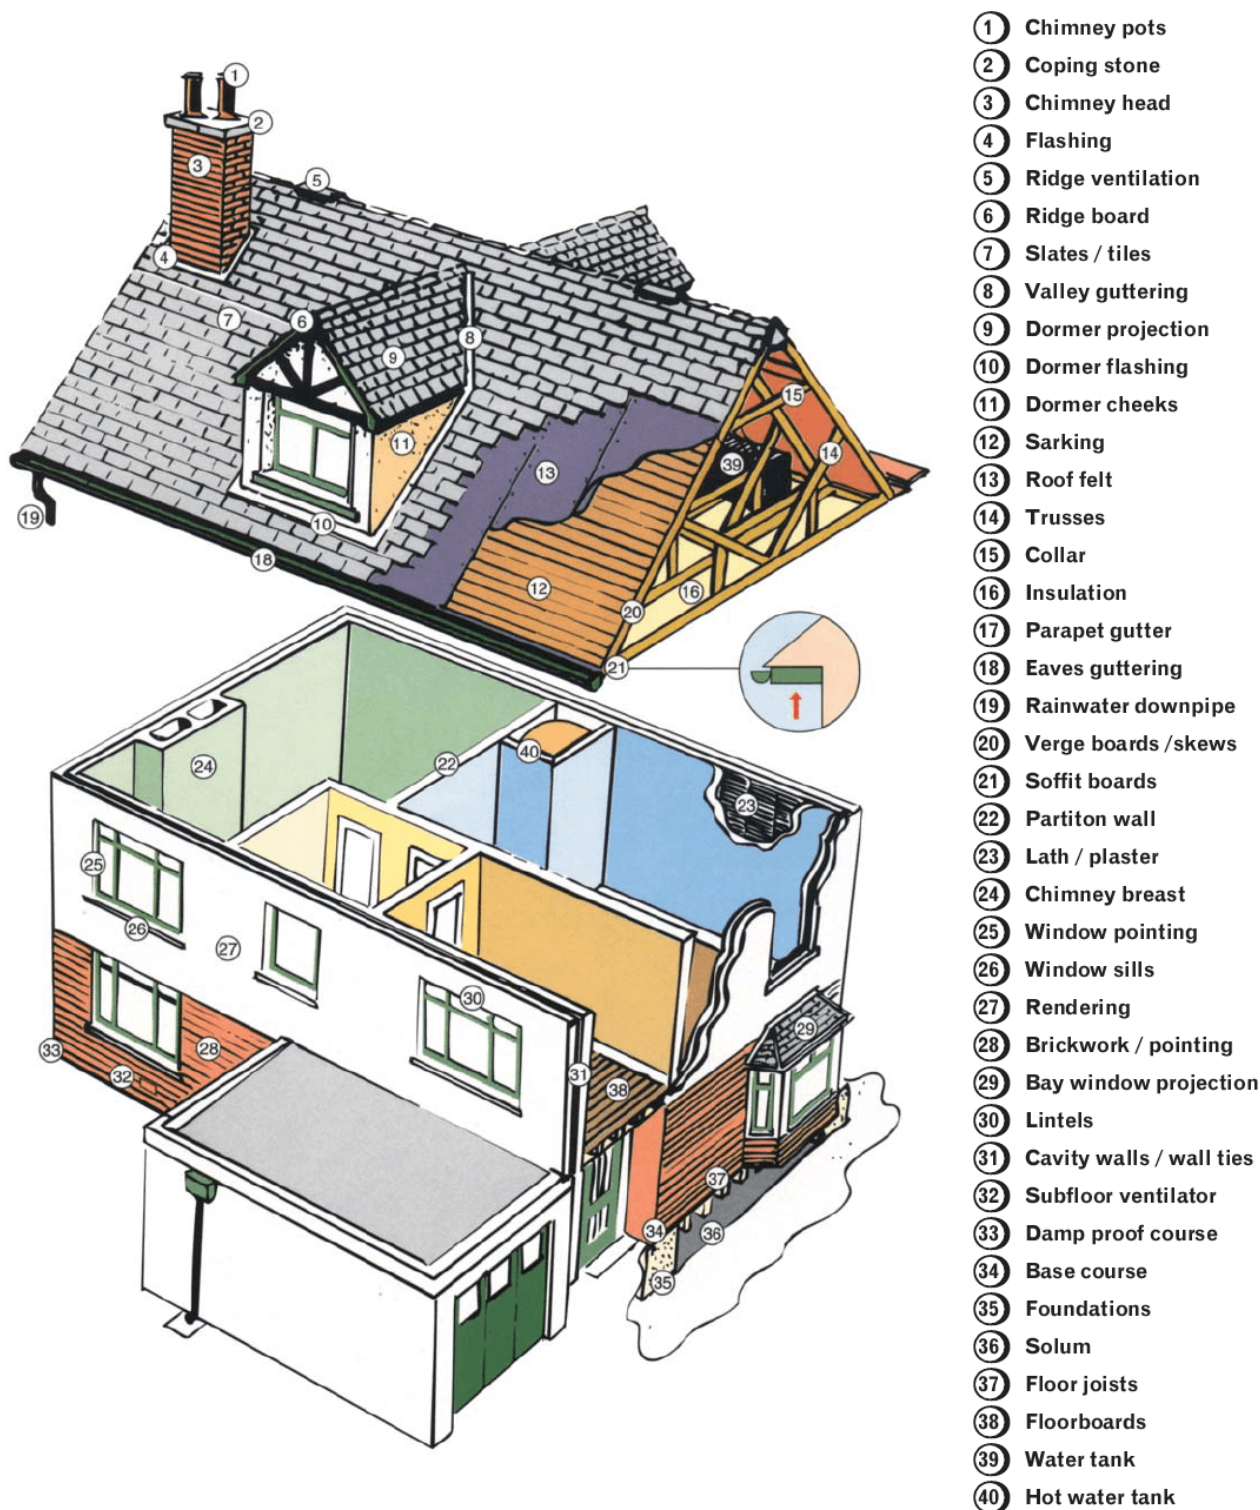
Sectional Diagram showing elements of a typical house

- ① Chimney pots
- ② Coping stone
- ③ Chimney head
- ④ Flashing
- ⑤ Ridge ventilation
- ⑥ Ridge board
- ⑦ Slates / tiles
- ⑧ Valley guttering
- ⑨ Dormer projection
- ⑩ Dormer flashing
- ⑪ Dormer cheeks
- ⑫ Sarking
- ⑬ Roof felt
- ⑭ Trusses
- ⑮ Collar
- ⑯ Insulation
- ⑰ Parapet gutter
- ⑱ Eaves guttering
- ⑲ Rainwater downpipe
- ⑳ Verge boards /skews
- ㉑ Soffit boards
- ㉒ Partiton wall
- ㉓ Lath / plaster
- ㉔ Chimney breast
- ㉕ Window pointing
- ㉖ Window sills
- ㉗ Rendering
- ㉘ Brickwork / pointing
- ㉙ Bay window projection
- ㉚ Lintels
- ㉛ Cavity walls / wall ties
- ㉜ Subfloor ventilator
- ㉝ Damp proof course
- ㉞ Base course
- ㉟ Foundations
- ㊱ Solum
- ㊲ Floor joists
- ㊳ Floorboards
- ㊴ Water tank
- ㊵ Hot water tank

Reference may be made in this report to some or all of the above component parts of the property. This diagram may assist you in locating and understanding these items.
