HOME REPORT

FLAT 0/5
10 PARK CIRCUS PLACE
GLASGOW
G3 6AN

Energy Performance Certificate (EPC)

FLAT 0/5 , 10 PARK CIRCUS PLACE, GLASGOW, G3 6AN

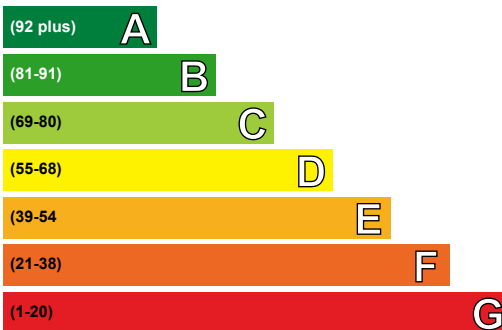
Energy Efficiency Rating

Current	Potential
78	78

This graph shows the current efficiency of your home, taking into account both energy efficiency and fuel costs. The higher this rating, the lower your fuel bills are likely to be.

Your current rating is **band C (78)**. The average rating for EPCs in Scotland is **band D (61)**.

The potential rating shows the effect of undertaking all of the improvement measures listed within your recommendations report.

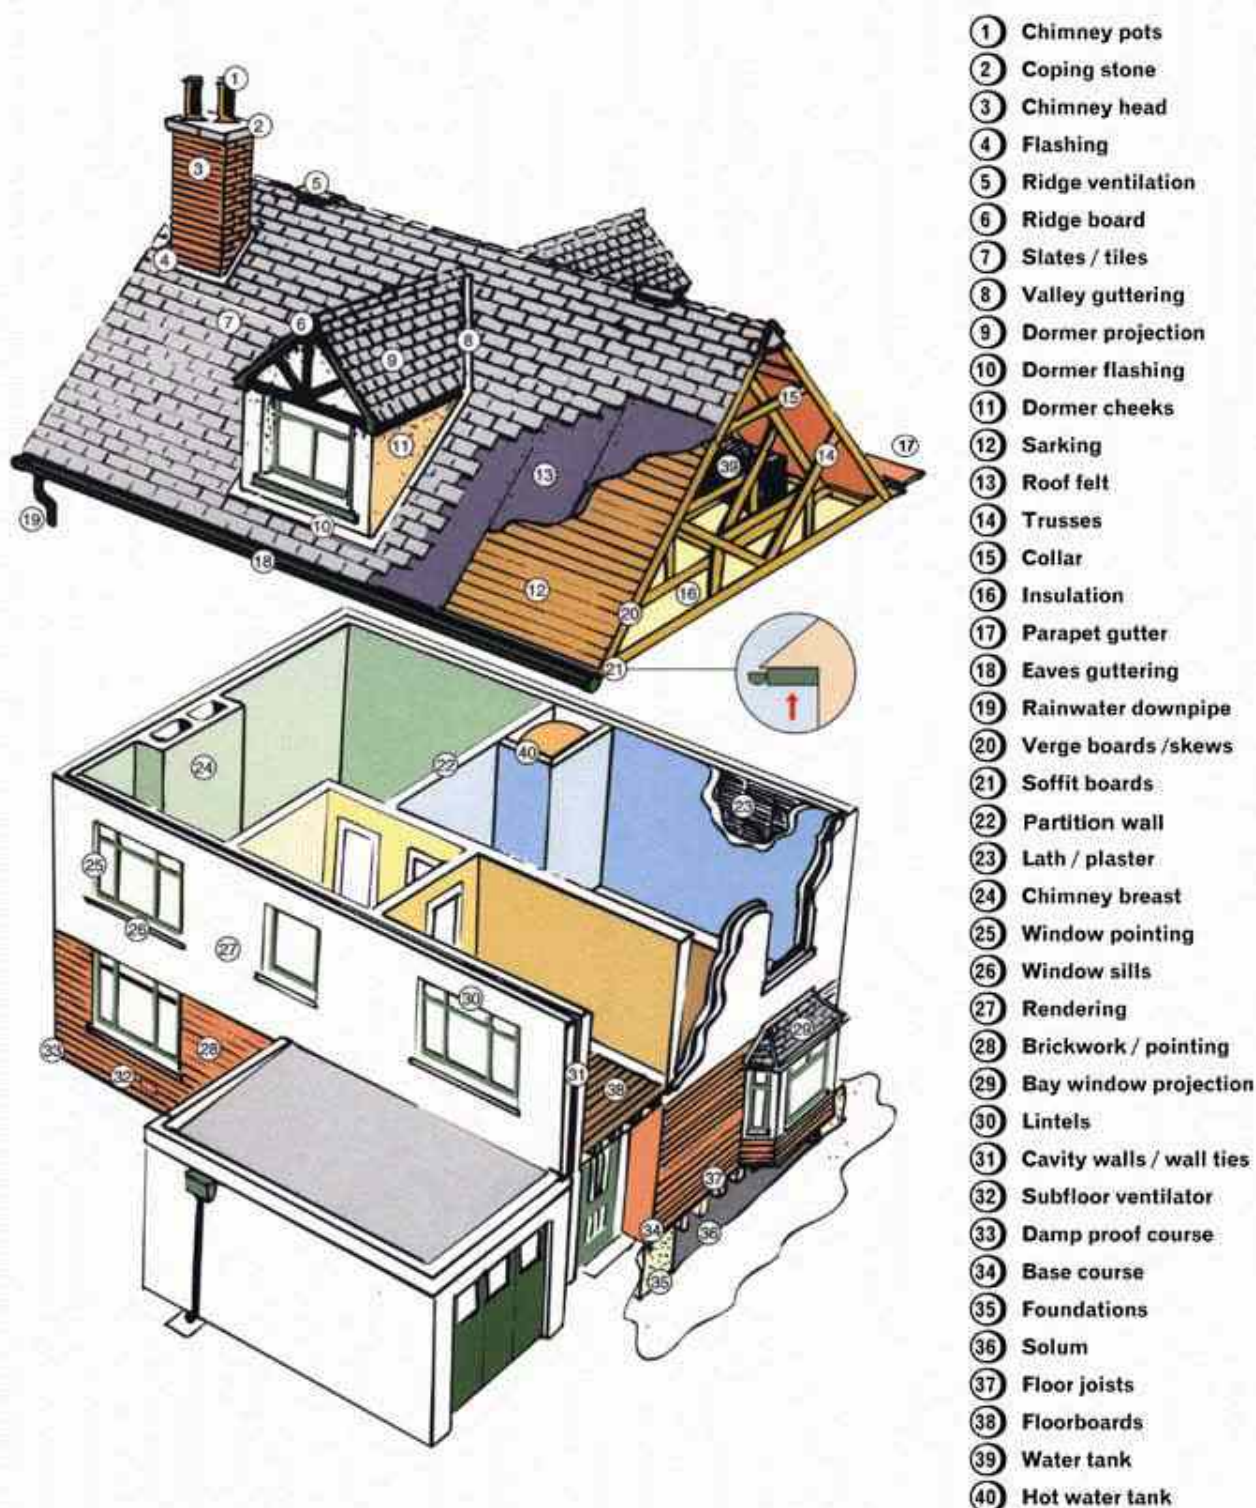
Sectional Diagram showing elements of a typical house

Reference may be made in this report to some or all of the above component parts of the property. This diagram may assist you in locating and understanding these items.
