# HARVEY DONALDSON & GIBSON

## survey report on:

,
Property address	6 Lochend Place, Troon, KA10 6DU
Customer	Mr R Martin, Mrs J Martin
Customer address	
Prepared by	Harvey Donaldson And Gibson
Date of inspection	18th October 2023

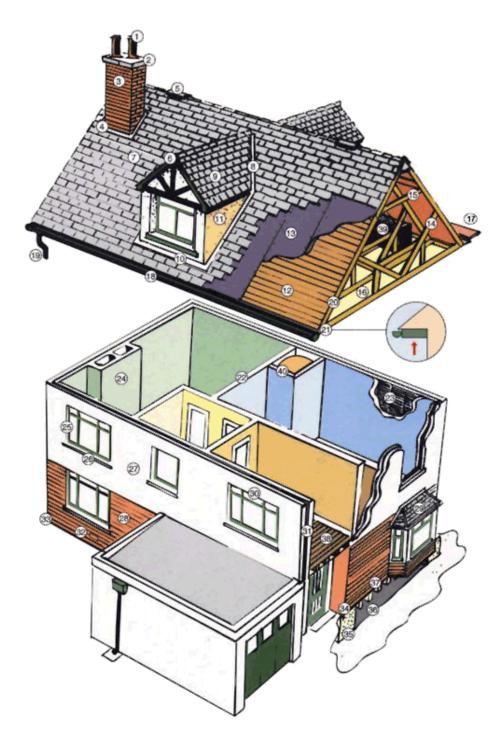
## Sectional Diagram showing elements of a typical house

Reference may be made in this report to some or all of the above component parts of the property. This diagram may assist you in locating and understanding these items.

- 1) Chimney pots
- 2) Coping stone
- 3) Chimney head
- 4 Flashing
- 5 Ridge ventilation
- 6 Ridge board
- 7) Slates / tiles
- 8 Valley guttering
- 9 Dormer projection
- 10 Dormer flashing
- 11) Dormer cheeks
- (12) Sarking
- (13) Roof felt
- (14) Trusses
- 15) Collar
- 16) Insulation
- 17) Parapet gutter
- 18) Eaves guttering
- (19) Rainwater downpipe
- 20) Verge boards /skews
- 21) Soffit boards
- 22) Partition wall
- 23) Lath / plaster
- 24) Chimney breast
- (25) Window pointing
- 6) Window sills
- 27) Rendering
- (28) Brickwork / pointing
- 29) Bay window projection
- 30 Lintels
- 31) Cavity walls / wall ties
- 32) Subfloor ventilator
- (33) Damp proof course
- 34) Base course
- 35) Foundations
- 36) Solum
- Floor joists
- 38) Floorboards
- 39) Water tank
- 40 Hot water tank
