YOUR ONESURVEY
HOME REPORT

107 Broomhill Drive
Glasgow
G11 7NA

SINGLE SURVEY

Sectional Diagram showing elements of a typical house

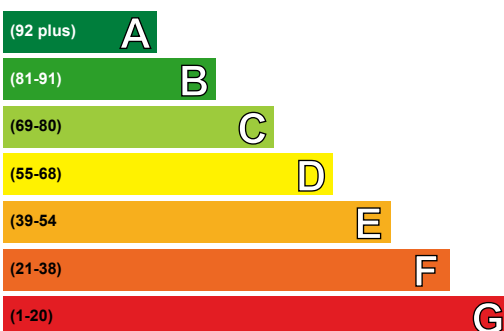
Energy Efficiency Rating

Very energy efficient - lower running costs

Current	Potential
64	77

Not energy efficient - higher running costs

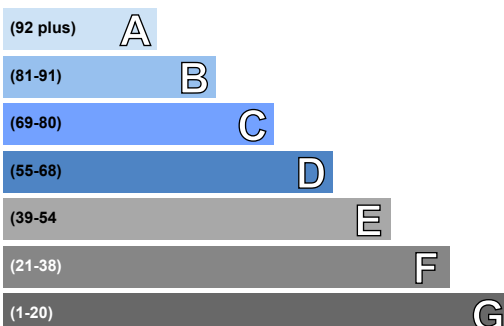
Environmental Impact (CO₂) Rating

Very environmentally friendly - lower CO₂ emissions

Current	Potential
58	76
