YOUR ONESURVEY  
**HOME REPORT**

35 Clouston Street  
North Kelvinside  
Glasgow  
G20 8QR

# SINGLE SURVEY

# Single Survey

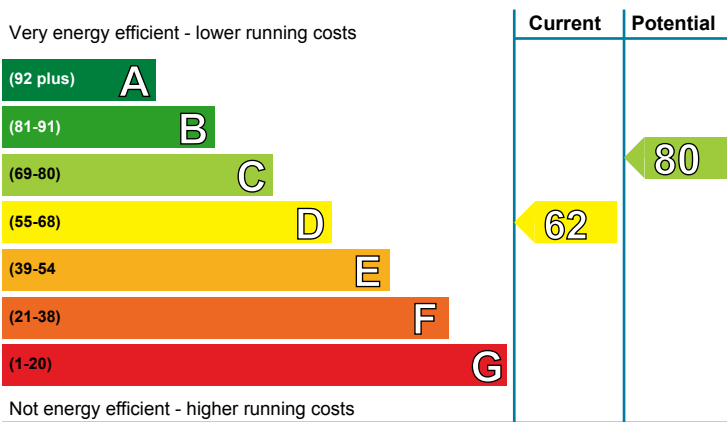
### Energy Efficiency Rating

This graph shows the current efficiency of your home, taking into account both energy efficiency and fuel costs. The higher this rating, the lower your fuel bills are likely to be.

Your current rating is **band D (62)**. The average rating for EPCs in Scotland is **band D (61)**.

The potential rating shows the effect of undertaking all of the improvement measures listed within your recommendations report.

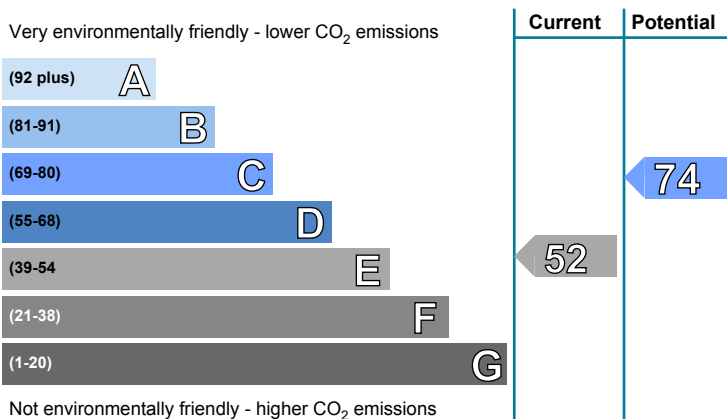
### Environmental Impact (CO<sub>2</sub>) Rating

This graph shows the effect of your home on the environment in terms of carbon dioxide (CO<sub>2</sub>) emissions. The higher the rating, the less impact it has on the environment.
