Home Report

Scottish Single Survey

Property address	8 John Allan Drive Cumnock KA18 3AE
Customer	Darren Davidson
Customer address	8 John Allan Drive Cumnock KA18 3AE
Prepared by	Shepherd Chartered Surveyors
Date of inspection	26/01/2024

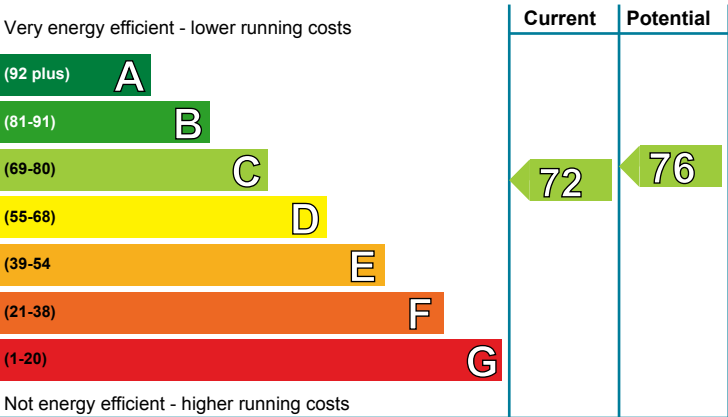
Energy Efficiency Rating

This graph shows the current efficiency of your home, taking into account both energy efficiency and fuel costs. The higher this rating, the lower your fuel bills are likely to be.

Your current rating is **band C (72)**. The average rating for EPCs in Scotland is **band D (61)**.

The potential rating shows the effect of undertaking all of the improvement measures listed within your recommendations report.

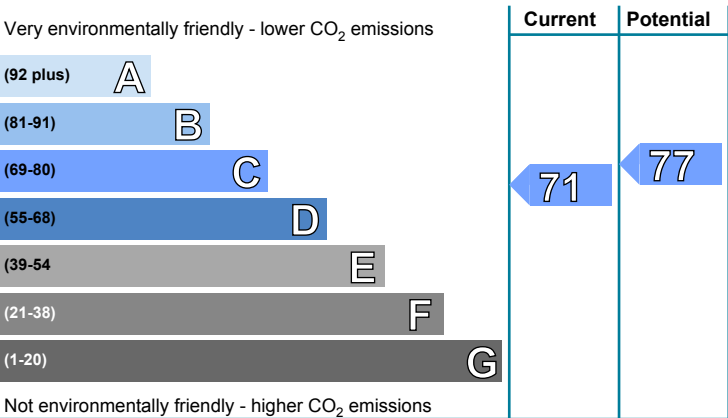
Environmental Impact (CO₂) Rating

This graph shows the effect of your home on the environment in terms of carbon dioxide (CO₂) emissions. The higher the rating, the less impact it has on the environment.
