# Home Report

# Scottish Single Survey

<b>Property address</b>	5/2 15 Randolph Gate Glasgow G11 7DQ
<b>Customer</b>	Gurpreet Singh
<b>Customer address</b>	5/2 15 Randolph Gate Glasgow G11 7DQ
<b>Prepared by</b>	Shepherd Chartered Surveyors
<b>Date of inspection</b>	11/03/2024

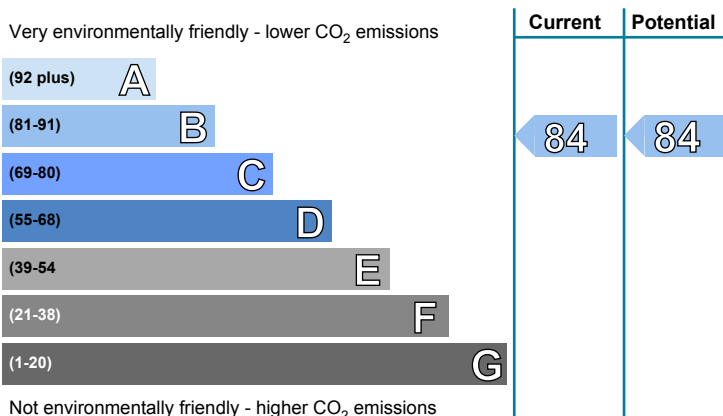
## Environmental Impact (CO<sub>2</sub>) Rating

This graph shows the effect of your home on the environment in terms of carbon dioxide (CO<sub>2</sub>) emissions. The higher the rating, the less impact it has on the environment.
