HOME REPORT

45 DORNAL DRIVE TROON KA10 7JZ

SINGLE SURVEY

Property address	45 DORNAL DRIVE, TROON, KA10 7JZ
Customer	Joan Kennedy
Customer address	
Prepared by	DM Hall LLP
Date of inspection	8th March 2024

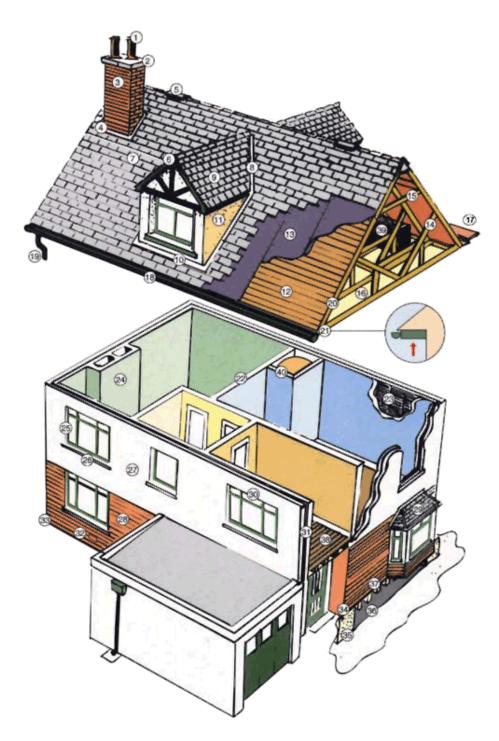
Sectional Diagram showing elements of a typical house

Reference may be made in this report to some or all of the above component parts of the property. This diagram may assist you in locating and understanding these items.

- 1) Chimney pots
- 2) Coping stone
- 3) Chimney head
- 4 Flashing
- 5) Ridge ventilation
- 6 Ridge board
- 7) Slates / tiles
- 8 Valley guttering
- 9 Dormer projection
- 10 Dormer flashing
- 11) Dormer cheeks
- (12) Sarking
- (13) Roof felt
- (14) Trusses
- (15) Collar
- 16 Insulation
- (17) Parapet gutter
- 18) Eaves guttering
- (19) Rainwater downpipe
- 20) Verge boards /skews
- 21) Soffit boards
- 22) Partition wall
- 23) Lath / plaster
- 24) Chimney breast
- 25) Window pointing
- 6) Window sills
- 27) Rendering
- (28) Brickwork / pointing
- 29) Bay window projection
- 30 Lintels
- (31) Cavity walls / wall ties
- 32) Subfloor ventilator
- (33) Damp proof course
- 34) Base course
- 35) Foundations
- 36) Solum
- 37) Floor joists
- 38) Floorboards
- 39) Water tank
- 40) Hot water tank
