Home Report

Scottish Single Survey

Property address	56 Riverside Park Linnpark Avenue Glasgow G44 3PG
-------------------------	--

Prepared by	Shepherd Chartered Surveyors
--------------------	------------------------------

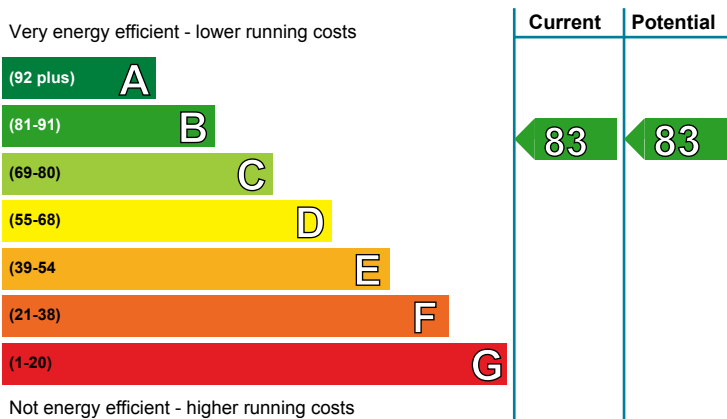
Energy Efficiency Rating

This graph shows the current efficiency of your home, taking into account both energy efficiency and fuel costs. The higher this rating, the lower your fuel bills are likely to be.

Your current rating is **band B (83)**. The average rating for EPCs in Scotland is **band D (61)**.

The potential rating shows the effect of undertaking all of the improvement measures listed within your recommendations report.

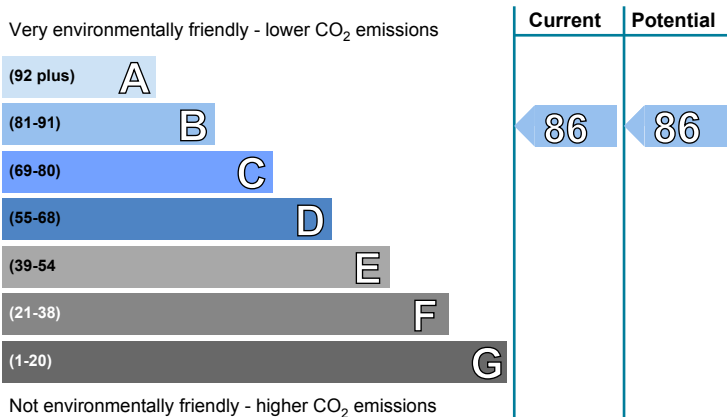
Environmental Impact (CO₂) Rating

This graph shows the effect of your home on the environment in terms of carbon dioxide (CO₂) emissions. The higher the rating, the less impact it has on the environment.
