# Home Report

# Single Survey

Property address	2/1 27 Leven Street Glasgow G41 2JD
Customer	David Pieraccini-Partington
Customer address	2/1 27 Leven Street Glasgow G41 2JD
Prepared by	Shepherd Chartered Surveyors
Date of inspection	11/04/2024

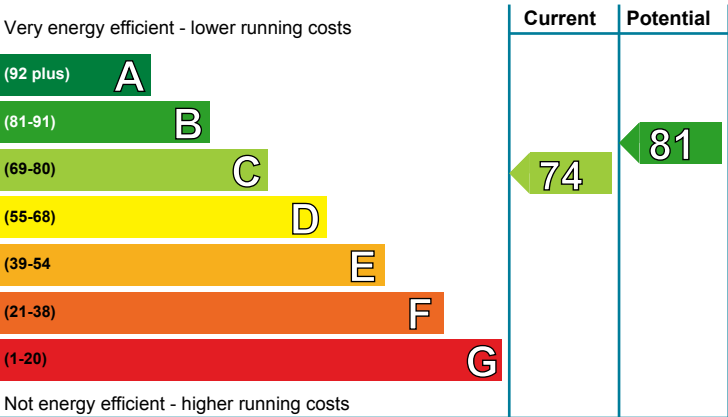
**Energy Efficiency Rating**

This graph shows the current efficiency of your home, taking into account both energy efficiency and fuel costs. The higher this rating, the lower your fuel bills are likely to be.

Your current rating is **band C (74)**. The average rating for EPCs in Scotland is **band D (61)**.

The potential rating shows the effect of undertaking all of the improvement measures listed within your recommendations report.

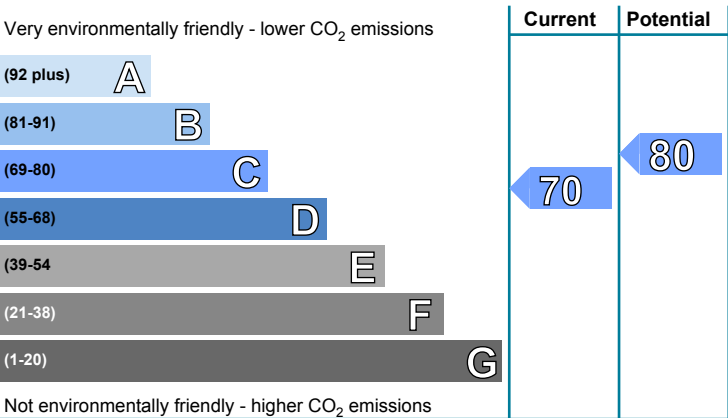
**Environmental Impact (CO<sub>2</sub>) Rating**

This graph shows the effect of your home on the environment in terms of carbon dioxide (CO<sub>2</sub>) emissions. The higher the rating, the less impact it has on the environment.
