# Home Report

# Single Survey

<b>Property address</b>	21a Greenhill Avenue Giffnock Glasgow G46 6QX
-------------------------	--

<b>Prepared by</b>	Shepherd Chartered Surveyors
--------------------	------------------------------

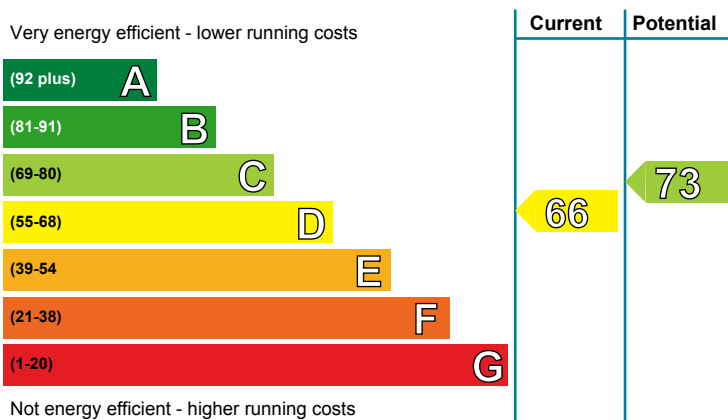
## Energy Efficiency Rating

This graph shows the current efficiency of your home, taking into account both energy efficiency and fuel costs. The higher this rating, the lower your fuel bills are likely to be.

Your current rating is **band D (66)**. The average rating for EPCs in Scotland is **band D (61)**.

The potential rating shows the effect of undertaking all of the improvement measures listed within your recommendations report.

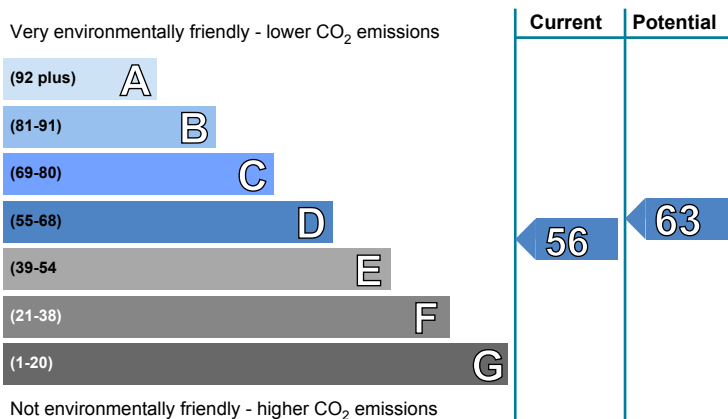
## Environmental Impact (CO<sub>2</sub>) Rating

This graph shows the effect of your home on the environment in terms of carbon dioxide (CO<sub>2</sub>) emissions. The higher the rating, the less impact it has on the environment.
