YOUR ONESURVEY HOME REPORT

Flat 12 325 Carmunnock Road Glasgow G44 5HL

SINGLE SURVEY

Surveyor Reference	WH/0516/SC
Customer	Kevin Brown
Selling address	Flat 12 325 Carmunnock Road Glasgow G44 5HL
Date of Inspection	20/03/2024
Prepared by	Gary Firth, MRICS Glasgow South - Allied Surveyors Scotland Plc

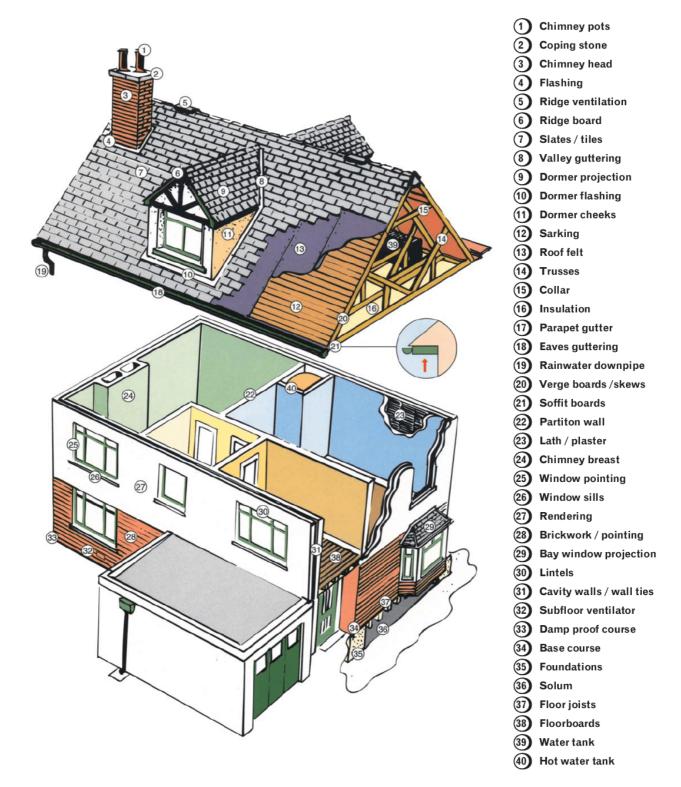
Sectional Diagram showing elements of a typical house

Reference may be made in this report to some or all of the above component parts of the property. This diagram may assist you in locating and understanding these items.
