HOME REPORT

2 CARRICK PARK
AYR
KA7 2SL

Energy Performance Certificate (EPC)

2 CARRICK PARK, AYR, KA7 2SL

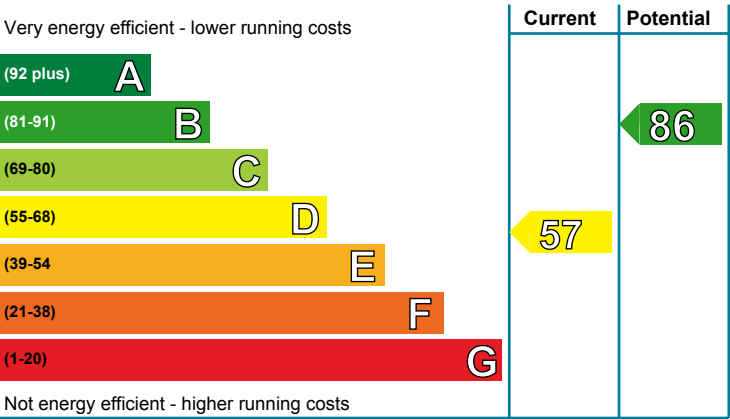
Energy Efficiency Rating

This graph shows the current efficiency of your home, taking into account both energy efficiency and fuel costs. The higher this rating, the lower your fuel bills are likely to be.

Your current rating is **band D (57)**. The average rating for EPCs in Scotland is **band D (61)**.

The potential rating shows the effect of undertaking all of the improvement measures listed within your recommendations report.

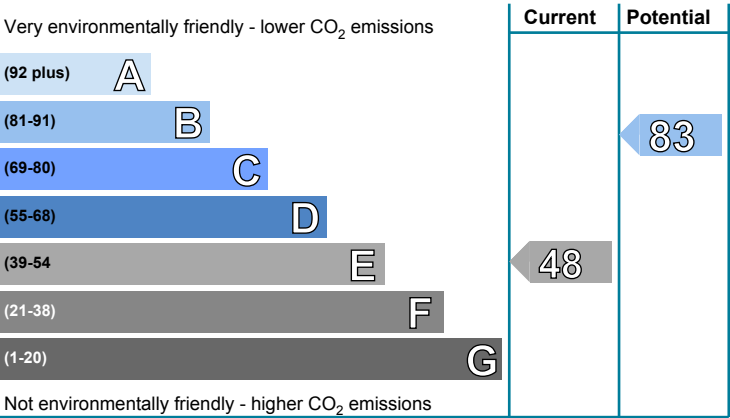
Environmental Impact (CO₂) Rating

This graph shows the effect of your home on the environment in terms of carbon dioxide (CO₂) emissions. The higher the rating, the less impact it has on the environment.

Your current rating is **band E (48)**. The average rating for EPCs in Scotland is **band D (59)**.

The potential rating shows the effect of undertaking all of the improvement measures listed within your recommendations report.

The average Scottish household produces about 6 tonnes of carbon dioxide every year. Based on this assessment, heating and lighting this home currently produces approximately 7.5 tonnes of carbon dioxide every year. Adopting recommendations in this report can reduce emissions and protect the environment. If you were to install all of these recommendations this could reduce emissions by 5.1 tonnes per year. You could reduce emissions even more by switching to renewable energy sources.
