# YOUR ONESURVEY HOME REPORT

55 Bute Street  
Gourock  
PA19 1SY

# SINGLE SURVEY

# Single Survey

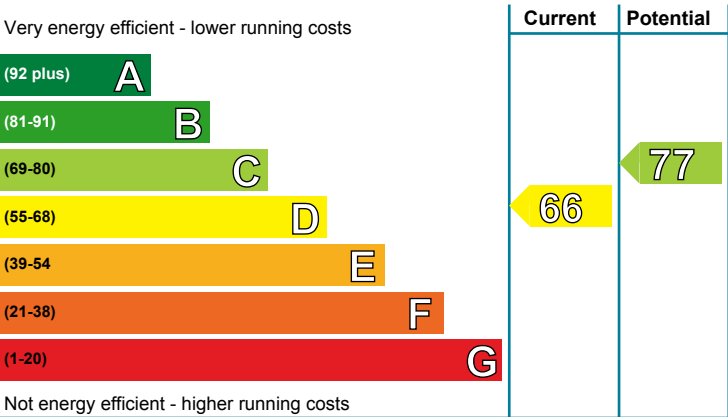
**Energy Efficiency Rating**

This graph shows the current efficiency of your home, taking into account both energy efficiency and fuel costs. The higher this rating, the lower your fuel bills are likely to be.

Your current rating is **band D (66)**. The average rating for EPCs in Scotland is **band D (61)**.

The potential rating shows the effect of undertaking all of the improvement measures listed within your recommendations report.

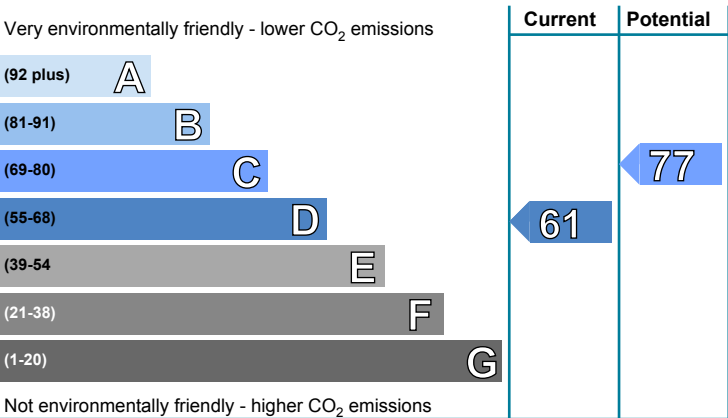
**Environmental Impact (CO<sub>2</sub>) Rating**

This graph shows the effect of your home on the environment in terms of carbon dioxide (CO<sub>2</sub>) emissions. The higher the rating, the less impact it has on the environment.
