# Home Report

# Scottish Single Survey

Property address	1 Up 45 Kirklee Road Glasgow G12 0SP
Customer	K Kane & E Smith
Customer address	1 Up 45 Kirklee Road Glasgow G12 0SP
Prepared by	Shepherd Chartered Surveyors
Date of inspection	15/04/2025

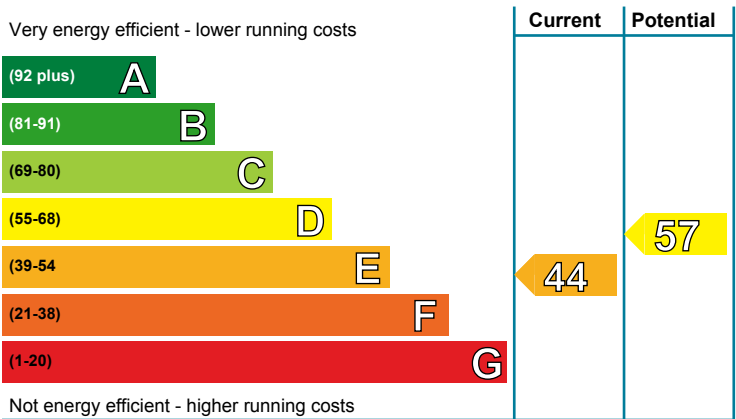
### Energy Efficiency Rating

This graph shows the current efficiency of your home, taking into account both energy efficiency and fuel costs. The higher this rating, the lower your fuel bills are likely to be.

The potential rating shows the effect of undertaking all of the improvement measures listed within your recommendations report.

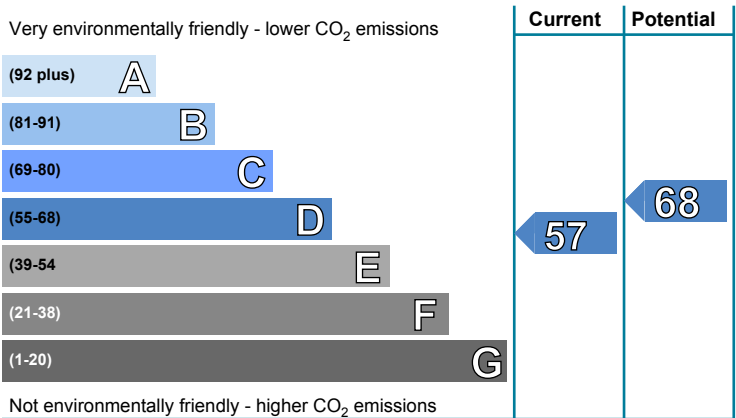
### Environmental Impact (CO<sub>2</sub>) Rating

This graph shows the effect of your home on the environment in terms of carbon dioxide (CO<sub>2</sub>) emissions. The higher the rating, the less impact it has on the environment.
