Home Report

Scottish Single Survey

Property address	0/1 32 Randolph Gate Glasgow G11 7DE
Customer	Mr Y & Mrs S Ali
Customer address	0/1 32 Randolph Gate Glasgow G11 7DE
Prepared by	Shepherd Chartered Surveyors
Date of inspection	29/07/2024

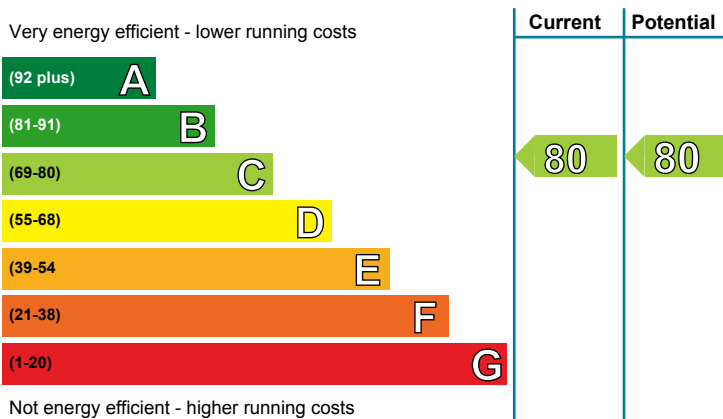
Energy Efficiency Rating

This graph shows the current efficiency of your home, taking into account both energy efficiency and fuel costs. The higher this rating, the lower your fuel bills are likely to be.

Your current rating is **band C (80)**. The average rating for EPCs in Scotland is **band D (61)**.

The potential rating shows the effect of undertaking all of the improvement measures listed within your recommendations report.
