# HOME REPORT

COTTAGE  
19 ASHGROVE  
CHURCH ROAD, QUARRIERS VILLAGE  
BRIDGE OF WEIR  
PA11 3TN

# Energy Performance Certificate (EPC)

COTTAGE 19 ASHGROVE, CHURCH ROAD, QUARRIERS VILLAGE, BRIDGE OF WEIR, PA11 3TN

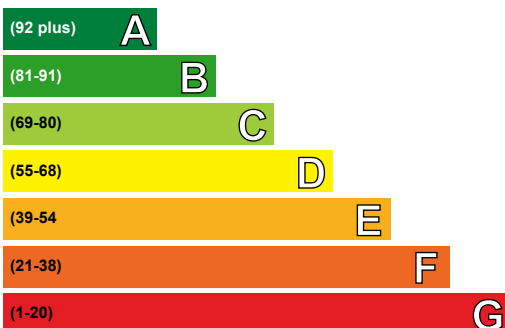
## Energy Efficiency Rating

Current	Potential
F 38	D 72

This graph shows the current efficiency of your home, taking into account both energy efficiency and fuel costs. The higher this rating, the lower your fuel bills are likely to be.

Your current rating is **band F (38)**. The average rating for EPCs in Scotland is **band D (61)**.

The potential rating shows the effect of undertaking all of the improvement measures listed within your recommendations report.
