# Scottish Single Survey

# survey report on:

Property address	Southpark House Southwood Road Troon KA9 1UP
------------------	---

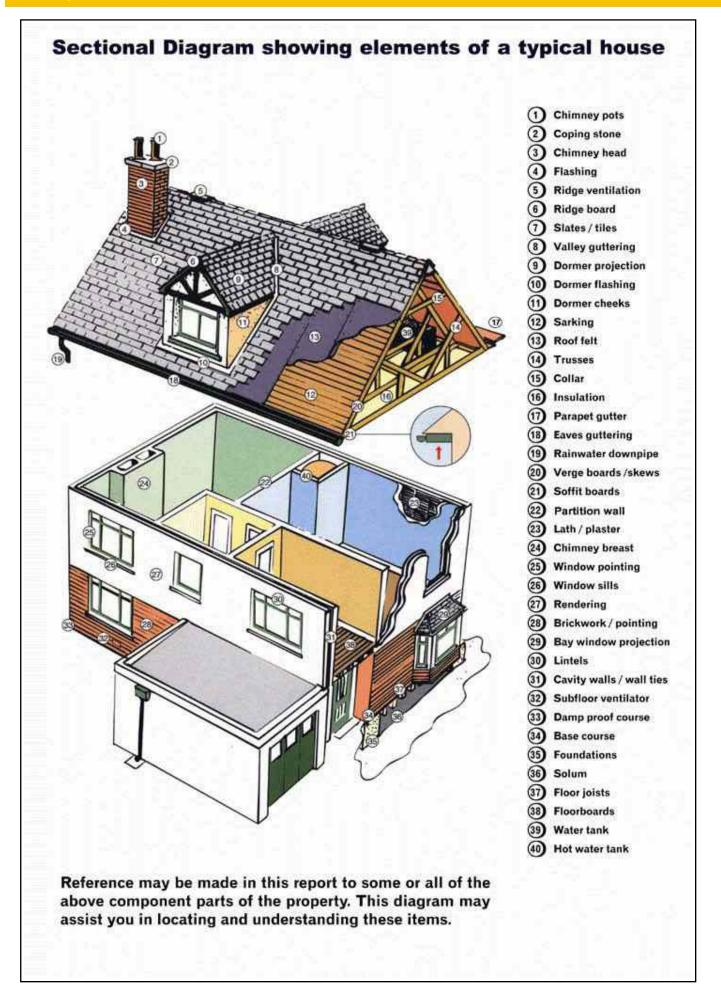
Several areas of roof pitch were not fully inspectable from ground level.
	Some areas of garden and boundary were obscured by mature vegetation.
