YOUR ONESURVEY HOME REPORT

Flat 3/1
10 Botanic Crescent
Glasgow
G20 8QQ

SINGLE SURVEY

Single Survey

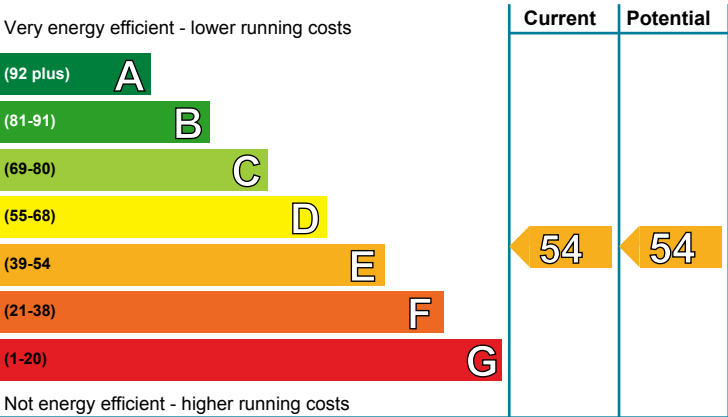
Energy Efficiency Rating

This graph shows the current efficiency of your home, taking into account both energy efficiency and fuel costs. The higher this rating, the lower your fuel bills are likely to be.

Your current rating is **band E (54)**. The average rating for EPCs in Scotland is **band D (61)**.

The potential rating shows the effect of undertaking all of the improvement measures listed within your recommendations report.

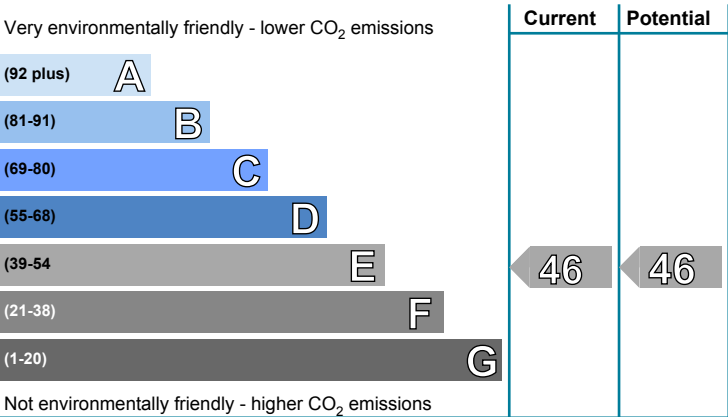
Environmental Impact (CO₂) Rating

This graph shows the effect of your home on the environment in terms of carbon dioxide (CO₂) emissions. The higher the rating, the less impact it has on the environment.
