YOUR ONESURVEY
HOME REPORT

88 Kelvin Court
Kelvinside
Glasgow
G12 0AH

SINGLE SURVEY

Single Survey

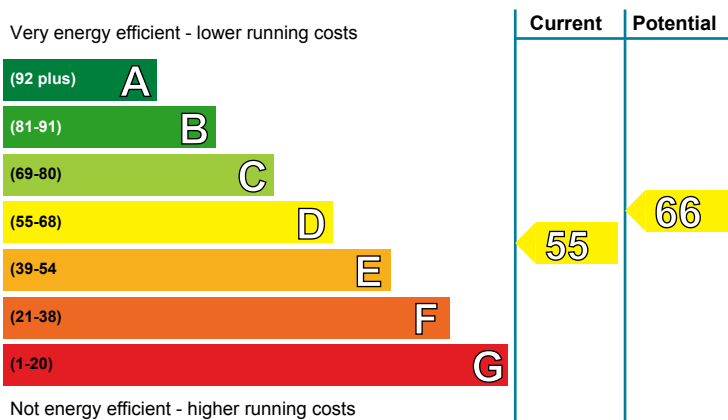
Energy Efficiency Rating

This graph shows the current efficiency of your home, taking into account both energy efficiency and fuel costs. The higher this rating, the lower your fuel bills are likely to be.

Your current rating is **band D (55)**. The average rating for EPCs in Scotland is **band D (61)**.

The potential rating shows the effect of undertaking all of the improvement measures listed within your recommendations report.

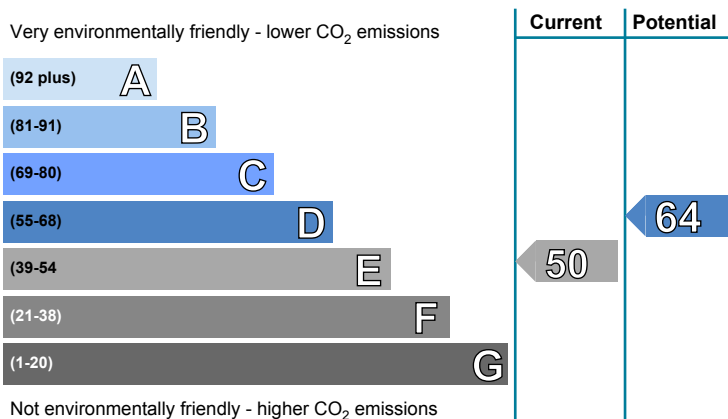
Environmental Impact (CO₂) Rating

This graph shows the effect of your home on the environment in terms of carbon dioxide (CO₂) emissions. The higher the rating, the less impact it has on the environment.
