# Home Report

# Scottish Single Survey

<b>Property address</b>	Flat 1 28 Huntly Gardens Glasgow G12 9AU
-------------------------	---

<b>Prepared by</b>	Shepherd Chartered Surveyors
--------------------	------------------------------

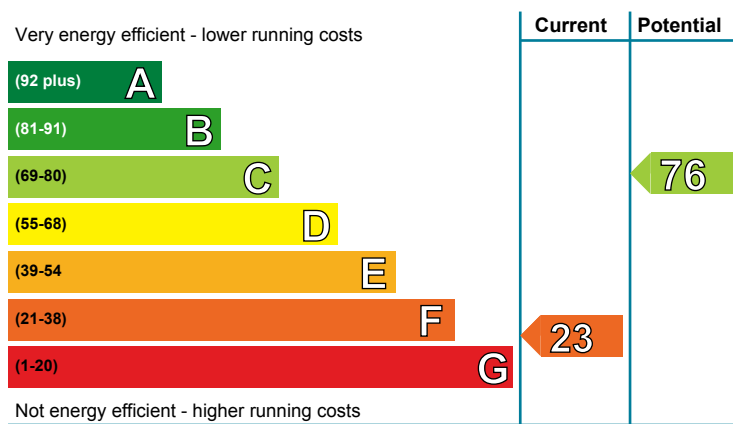
## Energy Efficiency Rating

This graph shows the current efficiency of your home, taking into account both energy efficiency and fuel costs. The higher this rating, the lower your fuel bills are likely to be.

Your current rating is **band F (23)**. The average rating for EPCs in Scotland is **band D (61)**.

The potential rating shows the effect of undertaking all of the improvement measures listed within your recommendations report.
