Home Report

Scottish
Single Survey

Property address	38 Strathgryffe Crescent Bridge of Weir PA11 3LG
Customer	Mrs B McGonigle
Customer address	38 Strathgryffe Crescent Bridge of Weir PA11 3LG
Prepared by	Shepherd Chartered Surveyors
Date of inspection	23/10/2024

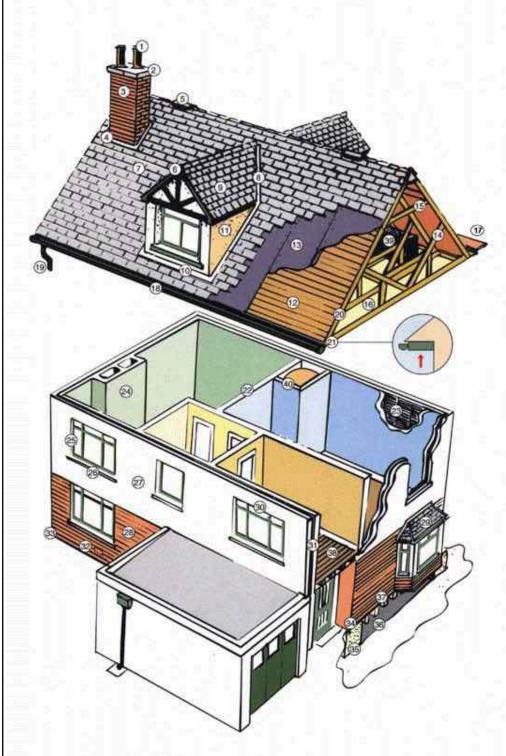
Sectional Diagram showing elements of a typical house

Reference may be made in this report to some or all of the above component parts of the property. This diagram may assist you in locating and understanding these items.

- 1) Chimney pots
- 2) Coping stone
- 3) Chimney head
- (4) Flashing
- 5) Ridge ventilation
- (6) Ridge board
- (7) Slates / tiles
- 8 Valley guttering
- 9 Dormer projection
- 10 Dormer flashing
- 11) Dormer cheeks
- (12) Sarking
- (13) Roof felt
- (14) Trusses
- (15) Collar
- 16) Insulation
- (17) Parapet gutter
- (18) Eaves guttering
- 19 Rainwater downpipe
- 20) Verge boards/skews
- 21) Soffit boards
- 22) Partition wall
- 23) Lath / plaster
- (24) Chimney breast
- 25) Window pointing
- 26) Window sills
- 27) Rendering
- (28) Brickwork / pointing
- 29) Bay window projection
- (30) Lintels
- (31) Cavity walls / wall ties
- 32) Subfloor ventilator
- (33) Damp proof course
- 34) Base course
- 35) Foundations
- 36) Solum
- Floor joists
- 38) Floorboards
- 39) Water tank
- 40) Hot water tank
