## **Home Report**

Scottish
Single Survey

Property address	12 Cavendish Drive Newton Mearns Glasgow G77 5NY
Customer	MR MARK GREENSHIELDS & MRS LOUISE PETTIGREW
Customer address	12 Cavendish Drive Newton Mearns Glasgow G77 5NY
Prepared by	Shepherd Chartered Surveyors
Date of inspection	04/03/2025

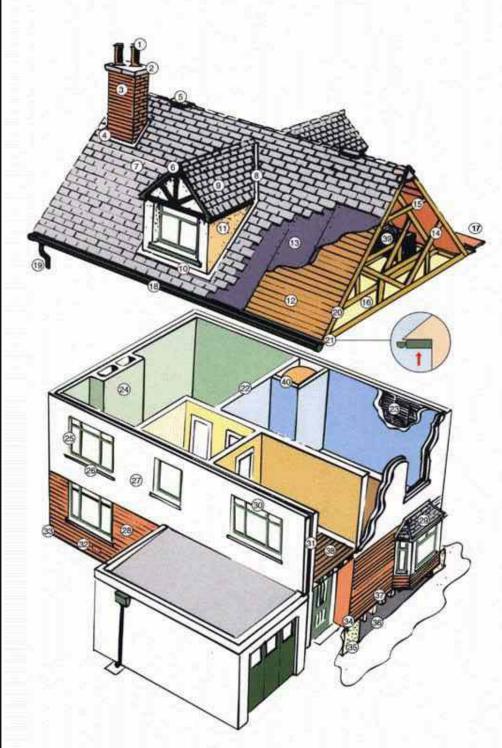
### Sectional Diagram showing elements of a typical house

Reference may be made in this report to some or all of the above component parts of the property. This diagram may assist you in locating and understanding these items.

- 1) Chimney pots
- 2) Coping stone
- 3) Chimney head
- (4) Flashing
- 5) Ridge ventilation
- 6 Ridge board
- 7 Slates / tiles
- 8 Valley guttering
- 9 Dormer projection
- 10) Dormer flashing
- 11) Dormer cheeks
- (12) Sarking
- 13) Roof felt
- (14) Trusses
- (15) Collar
- 16) Insulation
- (17) Parapet gutter
- 18) Eaves guttering
- (19) Rainwater downpipe
- 20) Verge boards/skews
- 21) Soffit boards
- 22) Partition wall
- 23) Lath / plaster
- (24) Chimney breast
- 25) Window pointing
- 26) Window sills
- 27) Rendering
- 28) Brickwork / pointing
- 29 Bay window projection
- (30) Lintels
- (31) Cavity walls / wall ties
- 32) Subfloor ventilator
- (33) Damp proof course
- 34) Base course
- 35) Foundations
- 36) Solum
- 37) Floor joists
- 8) Floorboards
- 39) Water tank
- (40) Hot water tank
