HOME REPORT

8 WHIRLIE ROAD
CROSSLEE
JOHNSTONE
PA6 7AG

ENERGY PERFORMANCE CERTIFICATE

Single Survey

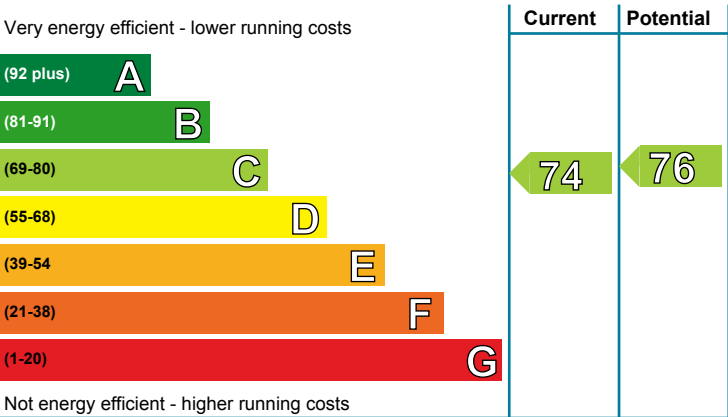
Energy Efficiency Rating

This graph shows the current efficiency of your home, taking into account both energy efficiency and fuel costs. The higher this rating, the lower your fuel bills are likely to be.

Your current rating is **band C (74)**. The average rating for EPCs in Scotland is **band D (61)**.

The potential rating shows the effect of undertaking all of the improvement measures listed within your recommendations report.

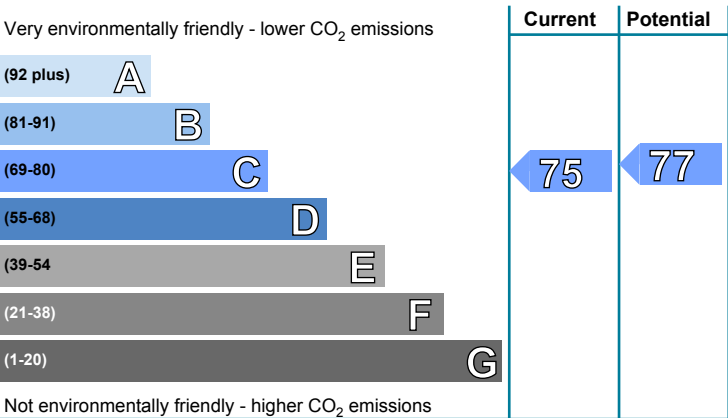
Environmental Impact (CO₂) Rating

This graph shows the effect of your home on the environment in terms of carbon dioxide (CO₂) emissions. The higher the rating, the less impact it has on the environment.

Your current rating is **band C (75)**. The average rating for EPCs in Scotland is **band D (59)**.

The potential rating shows the effect of undertaking all of the improvement measures listed within your recommendations report.
