# Home Report

# Single Survey

<b>Property address</b>	0/2 47 Novar Drive Glasgow G12 9UB
<b>Customer</b>	S Bainbridge & D Ladas
<b>Customer address</b>	0/2 47 Novar Drive Glasgow G12 9UB
<b>Prepared by</b>	Shepherd Chartered Surveyors
<b>Date of inspection</b>	07/11/2024

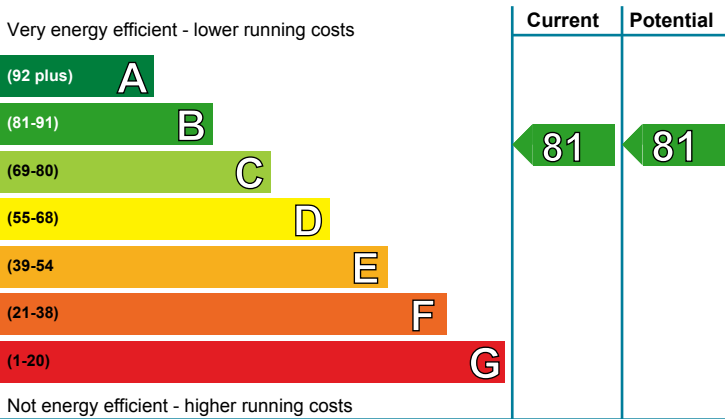
## Energy Efficiency Rating

This graph shows the current efficiency of your home, taking into account both energy efficiency and fuel costs. The higher this rating, the lower your fuel bills are likely to be.

Your current rating is **band B (81)**. The average rating for EPCs in Scotland is **band D (61)**.

The potential rating shows the effect of undertaking all of the improvement measures listed within your recommendations report.
