YOUR ONESURVEY
HOME REPORT

150 Caledonia Road
Ayr
KA7 3HR

Single Survey

Surveyor Reference	AE/4334
Customer	Mr. R Gardiner
Selling address	150 Caledonia Road Ayr KA7 3HR
Date of Inspection	13/02/2025
Prepared by	Mark Shanks, BSc MRICS Ayr - Allied Surveyors Scotland Ltd

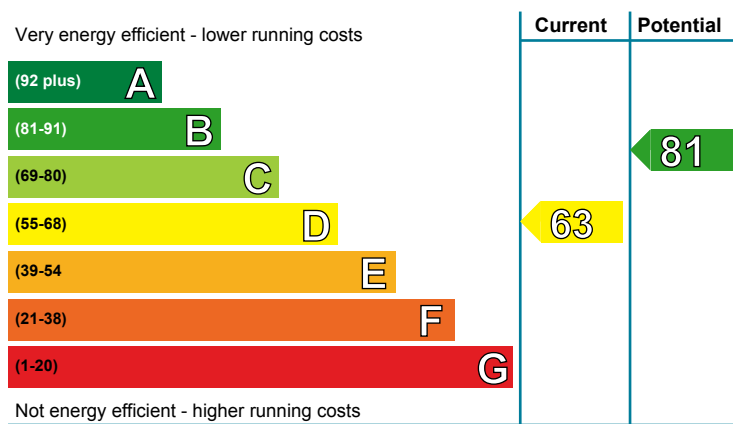
Energy Efficiency Rating

This graph shows the current efficiency of your home, taking into account both energy efficiency and fuel costs. The higher this rating, the lower your fuel bills are likely to be.

Your current rating is **band D (63)**. The average rating for EPCs in Scotland is **band D (61)**.

The potential rating shows the effect of undertaking all of the improvement measures listed within your recommendations report.
