Home Report

Scottish Single Survey

Single Survey

Property address	84 Queens Drive Glasgow G42 8BJ
Customer	SHIEKH MOHAMMED AKRAM
Customer address	84 Queens Drive Glasgow G42 8BJ
Prepared by	Shepherd Chartered Surveyors
Date of inspection	10/02/2025

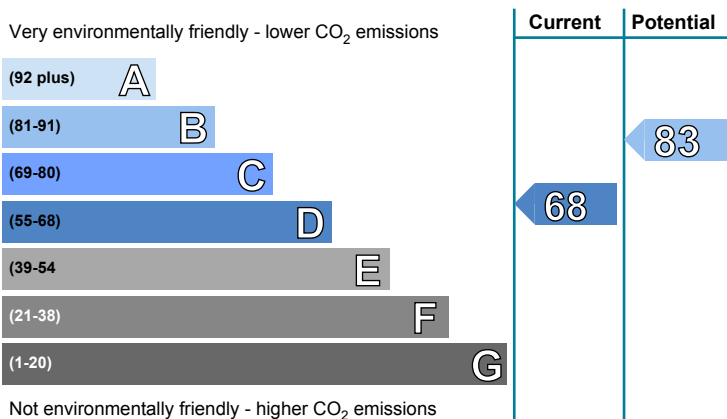
Environmental Impact (CO₂) Rating

This graph shows the effect of your home on the environment in terms of carbon dioxide (CO₂) emissions. The higher the rating, the less impact it has on the environment.
