# HOME REPORT

RAVENS CRAIG HORSEWOOD ROAD

BRIDGE OF WEIR  
PA11 3AT

RAVENSCRAIG, HORSEWOOD ROAD, BRIDGE OF WEIR, PA11 3AT

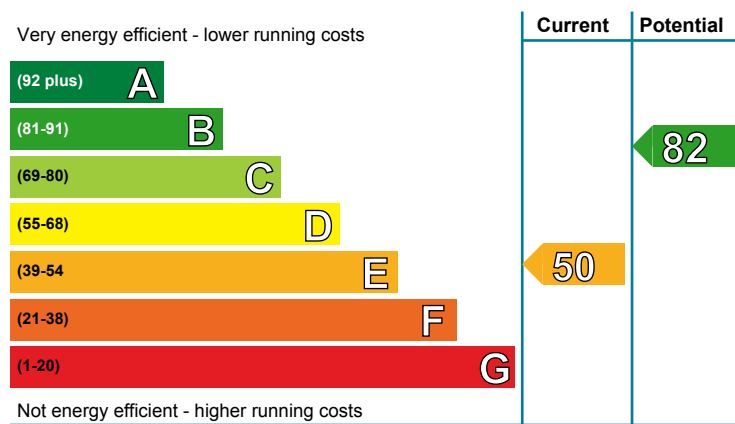
## Energy Efficiency Rating

This graph shows the current efficiency of your home, taking into account both energy efficiency and fuel costs. The higher this rating, the lower your fuel bills are likely to be.

Your current rating is **band E (50)**. The average rating for EPCs in Scotland is **band D (61)**.

The potential rating shows the effect of undertaking all of the improvement measures listed within your recommendations report.

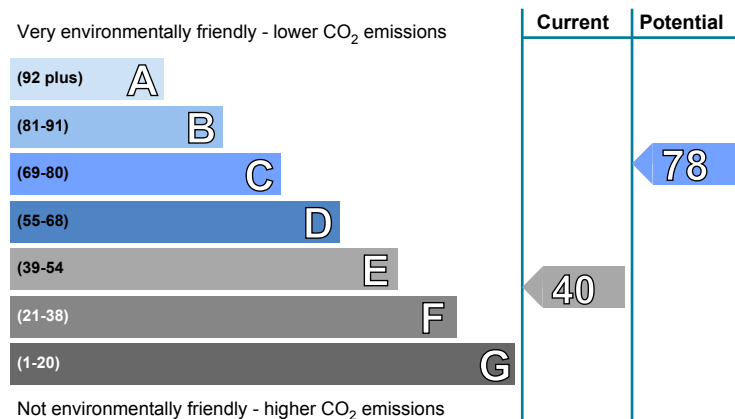
## Environmental Impact (CO<sub>2</sub>) Rating

This graph shows the effect of your home on the environment in terms of carbon dioxide (CO<sub>2</sub>) emissions. The higher the rating, the less impact it has on the environment.

Your current rating is **band E (40)**. The average rating for EPCs in Scotland is **band D (59)**.

The potential rating shows the effect of undertaking all of the improvement measures listed within your recommendations report.
